# Damage Assessment for Refinement Towers in Oil Installations using 3D Laser Scanning Technique

**Keywords-**Terrestrial Laser Scanner (TLS); 3D modeling; tower; Baiji refinery; as-built drawing

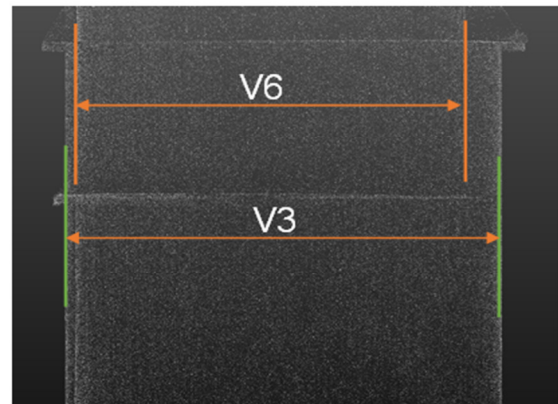
When observed from the north side, the southern portion of tower V3 appears obscured by the northern portion of tower V6, as portrayed in Figure 5. The visual overlap makes it difficult to detect any tilt, but when the image is amplified through the use of specialized software, the inclination becomes discernible, beginning at course 5. Furthermore, as

Fig. 5. View from the north.

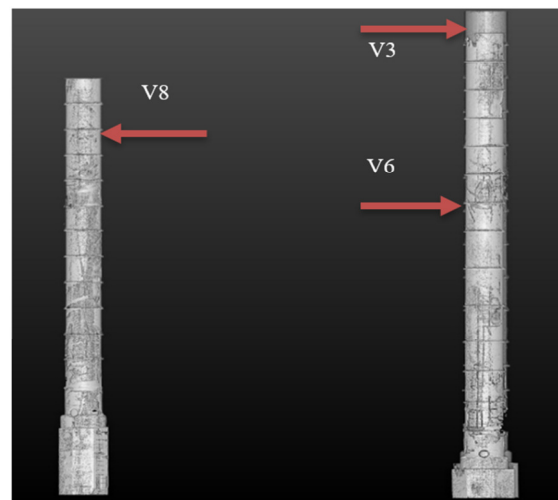
shown in Figure 6, tower V3 appears on the left side. It is noteworthy that the patterns observed in the south and west are analogous to those seen in the north and east.

Fig. 6. The appearance of the incline between the two towers from the left.

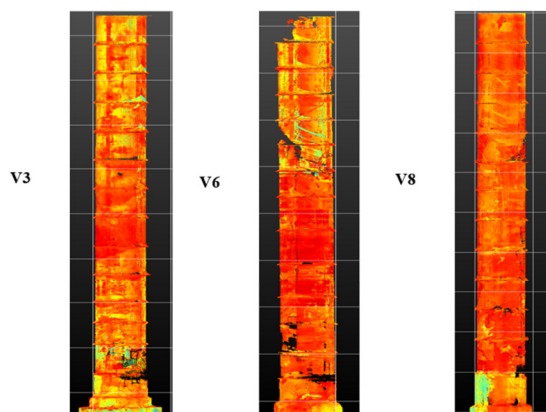
Conversely, the front view of the towers can be applied to the 2D network of perpendicular straight lines, with the vertical line serving as a reference for detecting indications. In this view, tower V6 exhibits a more pronounced inclination compared to the other towers, as illustrated in Figure 7. This observation underscores the necessity for the employment of supplementary techniques and tools to further analyze the tilt and determine its direction [13].

Fig. 7. Inclination by applying towers to a network of perpendicular straight lines.

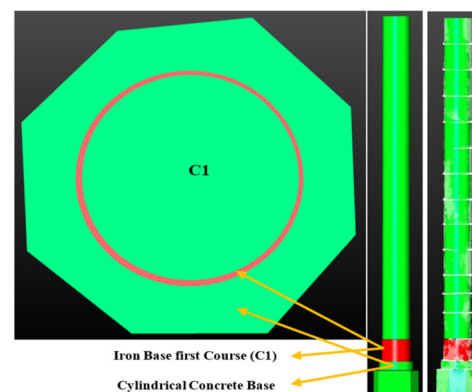
the north. This inclination remained constant until course number 9 at which point it increased to 1 cm. At the tower's zenith, the inclination reaches 2 cm, maintaining the same direction. No discernible inclination was observed towards either east or west, as presented in Table II and Figure 9.

Fig. 9. Front and top view illustrating the concrete base and the first course in green for tower V3.

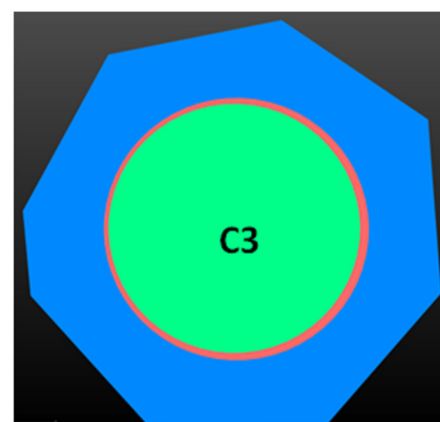
Fig. 11. The third course leans to the south 3 cm.

However, the inclination increases by 2 cm towards the south in the third course (C3). This inclination then continues to increase by 1 cm with each subsequent course in the same direction, as depicted in Figures 11 and 12. In the ninth course (C9), the inclination increases to 2 cm and then exhibits a return to an increase of 1 cm per course in the tenth course (C10). By the eleventh course (C11), the inclination has increased to 13 cm in the southern direction, with no inclination being observed in the eastern or western directions, as portrayed in Figure 13 and Table III.

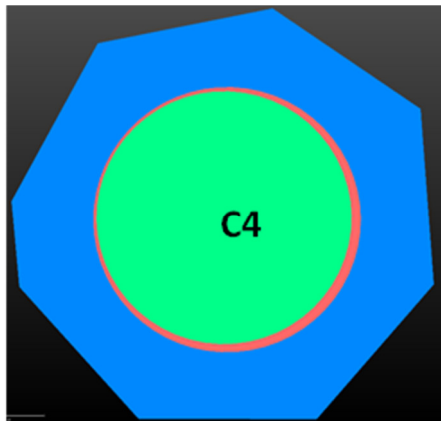
Fig. 12. The fourth course tends to the south 2 cm.

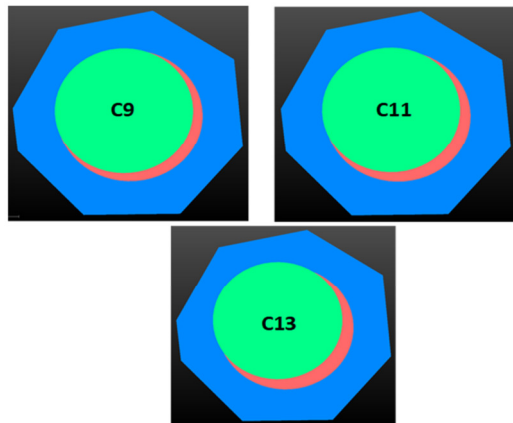
Fig. 13. The increase in inclination in the V6 tower.

The present analysis confirms that tower V6 is structurally unstable and must be removed, while towers V3 and V8 can be rehabilitated with periodic monitoring.

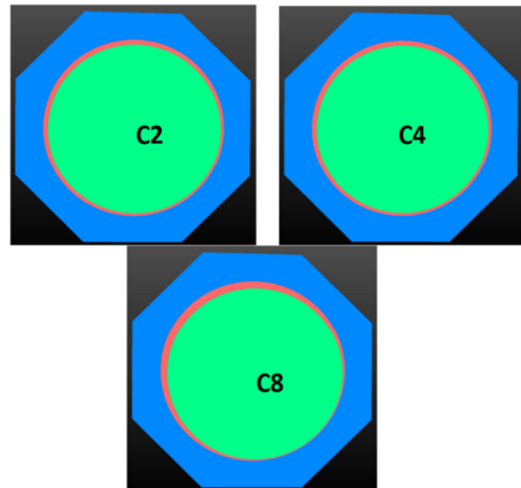
In the tower V8, no inclination is observed in the initial course (C1), as illustrated in Figure 14. The inclination begins in the second course (C2), with a slope of 1 cm to the north.

This inclination remains constant in the third course (C3) and subsequently increases to 2 cm in the fourth course (C4), where it remains stable. By the eighth course (C8), the inclination reaches 3 cm and remains constant toward the top of the tower, all in the same direction. No discernible inclination is observed in the east or west directions, as presented in Figure 14 and Table IV.

Fig. 14. The increase in the inclination in the V8 tower.
