Investigation of an Insulator Flashunder in an 150 kV OTL of the Power System of Crete

Islands Network Operation Department
Hellenic Electricity Distribution Network Operator S. A.
Greece
d.pylarinos@deddie.gr

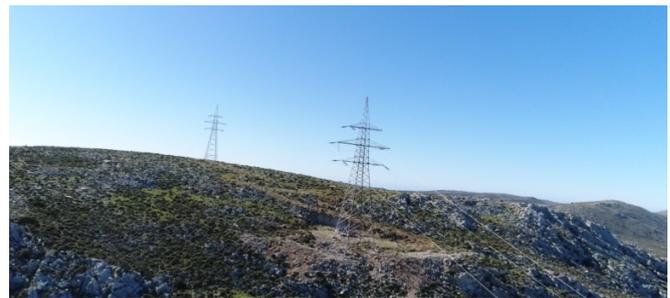
The fault was found in one of the two insulators in a double tension string in Tower 29, located 13.73 km away from Sitia. Towers 28 and 29 are double circuit tension towers with the extra circuit endings being used in a way that facilitates a phase transposition (Figure 5), the only one in the Cretan Transmission System. These towers, known to suffer from strong winds and intense humidity in early mornings, are located at the top of a steep hill (Figures 6-7). For all these reasons, and even though the distances recorded from the fault

Fig. 6. A view of the location of Towers 28 and 29
