# Overhead Transmission Line Maintenance in Crete and Rhodes: 2016-2020

D. Pylarinos

Islands Network Operation Department  
Hellenic Electricity Distribution Network Operator S. A.  
Greece  
d.pylarinos@deddie.gr

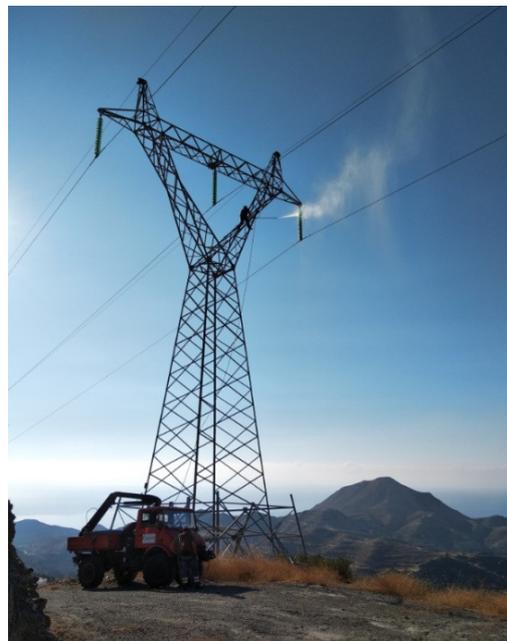
Marine pollution is significant due to the coastal development of the islands and of their transmission systems. This issue has been largely resolved with the replacement of ceramic insulators with composite ones in most lines [14]. Currently, only two lines are still equipped with ceramic insulators in Crete: the Chania-Kasteli and the Moires-Ierapetra lines. The Chania-Kasteli line faces minimal pollution issues due to natural washing [14, 18-20]. The Moires-Ierapetra line on the other hand, has to be washed once a year (Figure 4). The

Fig. 4. Dead washing of the Moires-Ierapetra line. The water is carried with trucks and pumped-up to the lineman that performs the washing. The line is to be refurbished and the new footings and base are visible.

line is to be refurbished in the near future however, and the refurbished line is to be equipped with composite insulators.

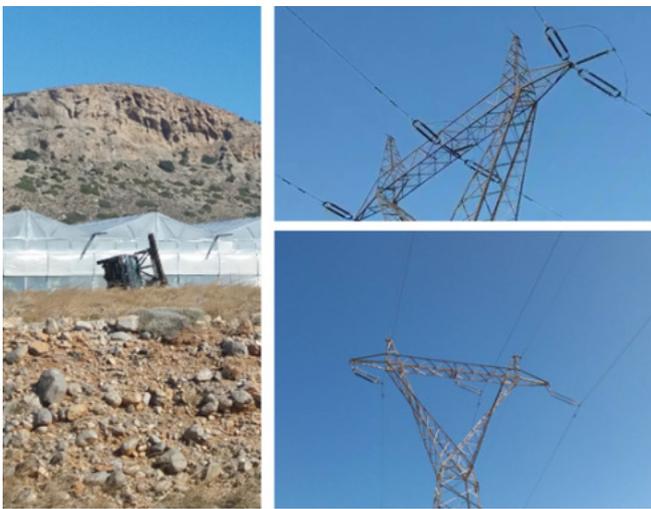
Another significant issue related to the local climate is the influence of winds. The OTLs in Crete experience more severe wind stress compared to the ones in Rhodes due to the island's shape, local weather patterns, the existence of mountains and gores in proximity to line routes etc [20]. The problem is fiercer near Atherinolakos. This was a known issue and additional weights were installed in most towers of the OTLs in the area, as well as silicone coated ceramic insulator strings in the jumper parts of tension towers (two such strings in certain towers). This suppressed the effect of wind in order to avoid clearance issues (as the ones shown in Figure 5), but the constant swinging motion has had a great effect on mechanical parts (shackles, clevises, bolts, pins, v-hangers etc) (Figures 6 and 7).

Fig. 5. A car tipped-over by the wind near Atherinolakos (left). Wind lift-off of conductors and/or jumper parts on lines not equipped with additional weights and/or ceramic insulators at jumper parts (right).

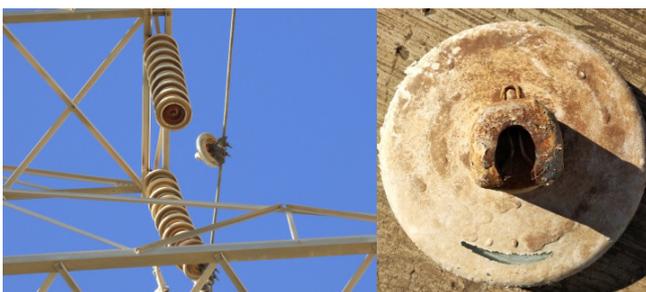
Fig. 6. A jumper part of a tension tower suspended by two coated glass strings (to avoid wind lift-offs). The last insulator of the right string was found unbuckled during inspection. As shown in the right picture, the insulator's cap was found misfigured.

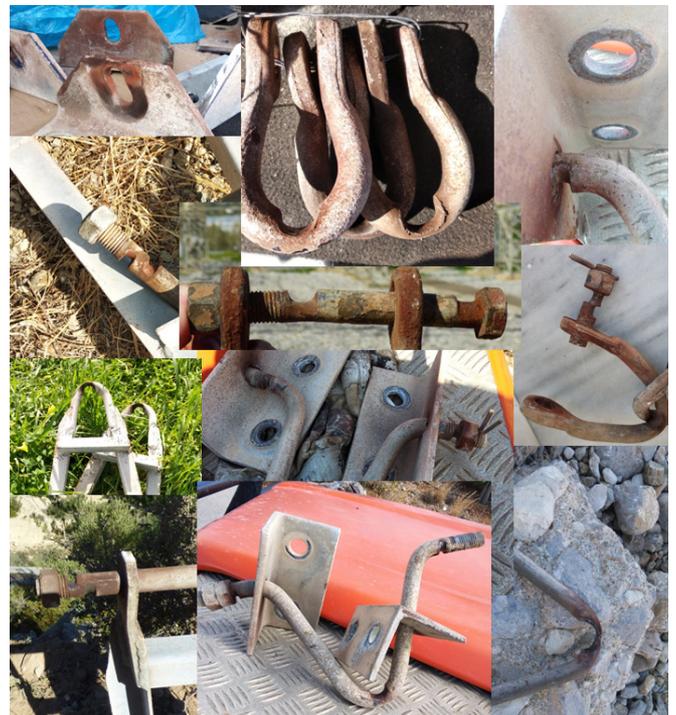
Fig. 7. A collection of pictures with various metal parts/fittings (shackles, clevises, bolts, pins, v-hangers etc) as removed from service.

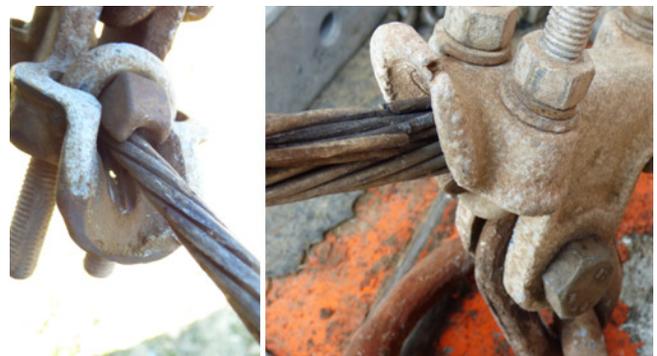
Fig. 8. Overhead ground wire issues: a damaged suspension clamp (left) and broken strands (right)

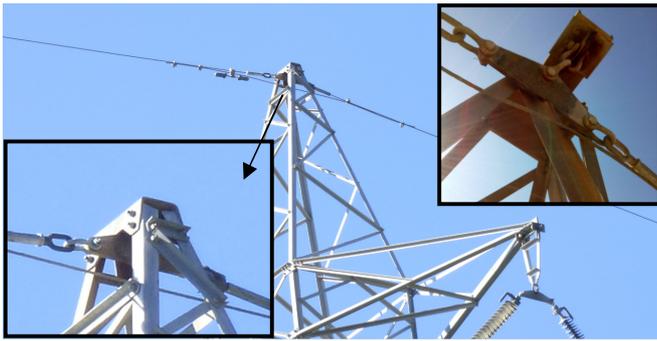
not require much inspection and maintenance during their first years of operation. This however proved erroneous especially for the Atherinolakos-Ierapetra line that suffered intense stress due to the winds in the area. In fact, a metal fitting replacement program had to be issued in early 2020 for most towers, in order to replace metal parts/fittings that supported the conductors (Figure 7). An additional issue was related to the overhead ground wire of the double circuit towers of this line. The wind effect had caused significant damage to suspension clamps (grips) and to the shield wires (Figure 8). Thus, it was decided to replace such clamps with yoke plates and dead-end tension clamps, effectually making suspension towers similar to tension towers (in terms of shield wire arrangement) while avoiding any contact with near angles (a problem faced in the past with single circuit towers) (Figure 9).

Fig. 9. An overhead shield wire arrangement on a double circuit suspension tower using a yoke plate and dead-end tension clamps to replace the initial suspension clamp, making the arrangement effectively similar to that of a tension tower. Down and left image: a zoom-in of the arrangement. Up and right image: A similar approach on a single circuit suspension tower proved problematic.

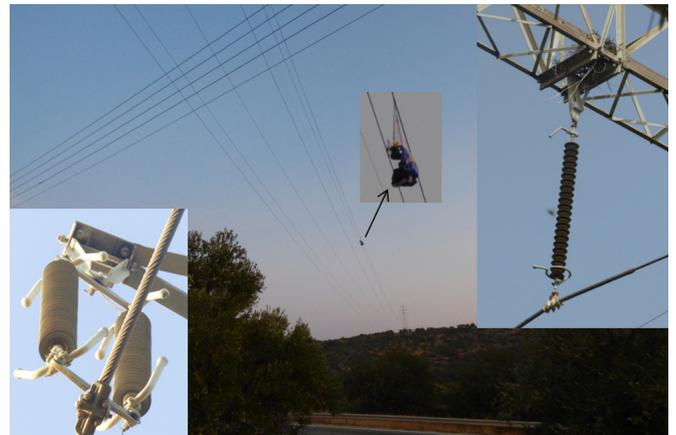
Fig. 11. Views of ground inspections, taken with a 60x optical zoom camera. Left image: A transient arc caused by a bird carrying a string. The arc traces are visible on the arcing horn of the right insulator along with a piece of string. Middle image: a potentially dangerous object on a conductor midway of the span, as seen from near one of the towers (natural and zoomed in view). Right image: a nest right above of an insulator.

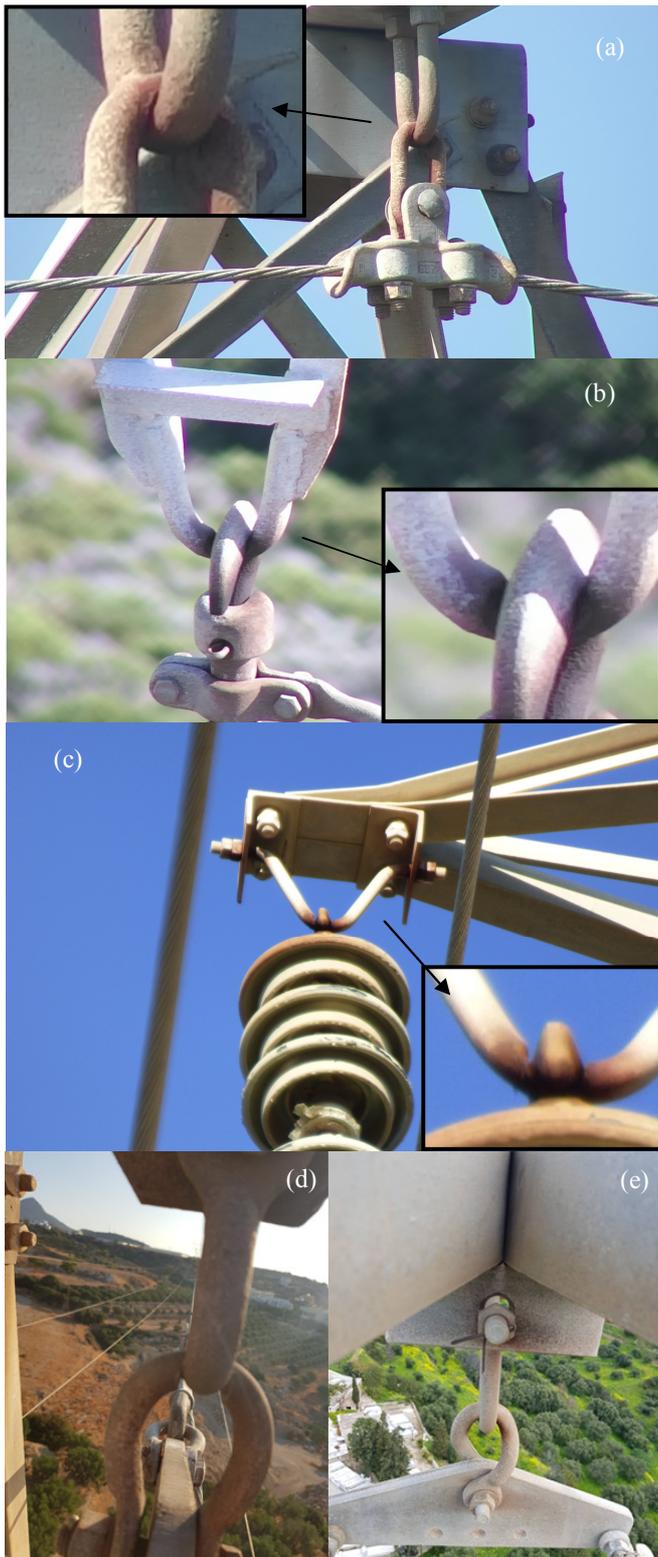
Fig. 13. Inspection photos. (a) and (b): drone photos, (c): photos taken from the ground, using a 60x zoom camera. (d) and (e): climbing inspection views. Pictures within pictures in (a)-(c) are zoomed in details of the larger respective pictures. Notice that even when the viewing angle from the ground allows to spot an issue, the severity of the issue can not be safely assessed.

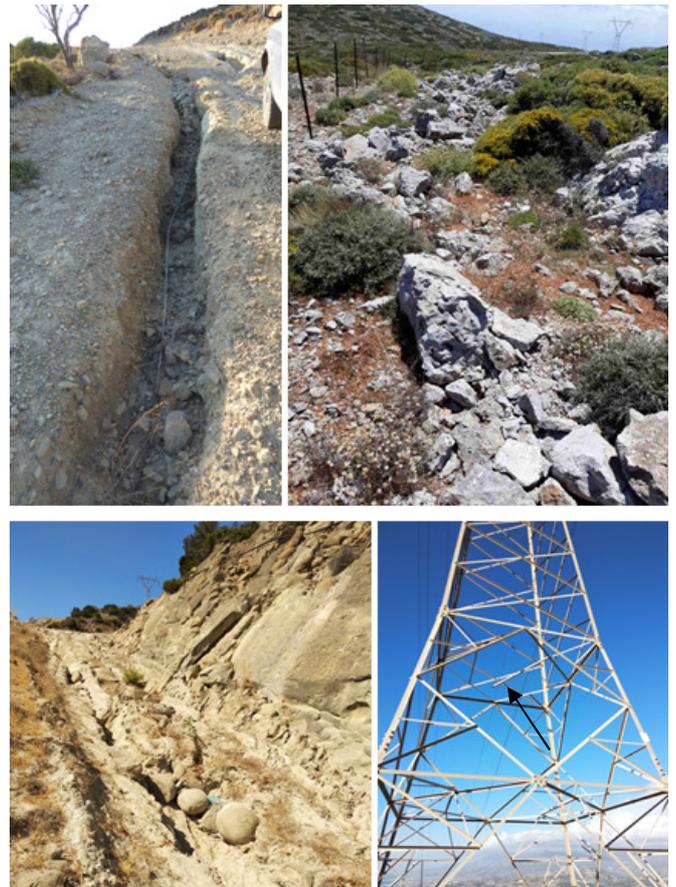
Fig. 14. Maintenance works on the ground: an exposed ground conductor, impassable roads and a hanging angle in a tower's body (noted with an arrow).

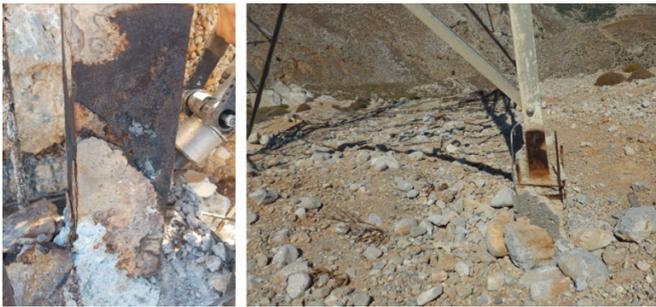
Fig. 15. Typical images from footing corrosion in South Rhodes-Gennadi and Atherinolakos-Ierapetra OTLs

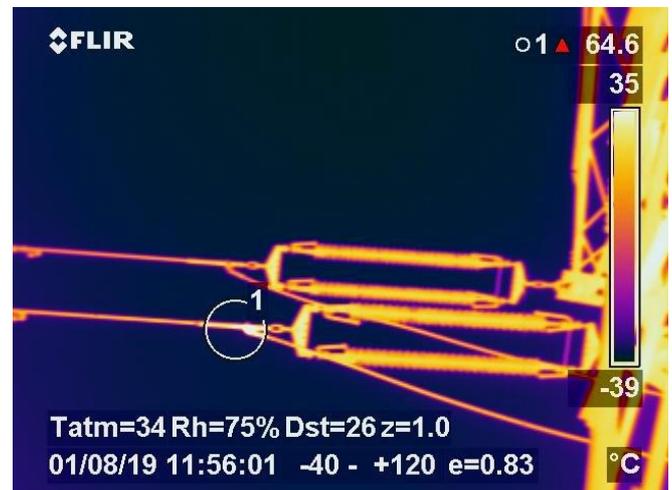
Fig. 16. A typical image acquired by a thermal camera from the ground showing a typical issue (a hot spot in the jumper connection).

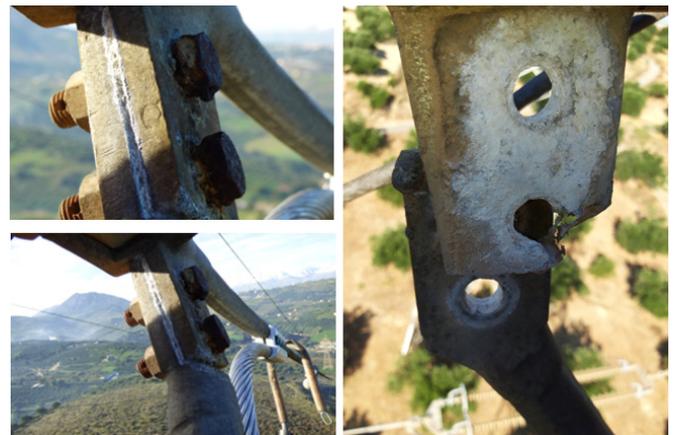
Poor connections may result to hot spots that may ultimately result to melted bolts and to a generally poor state of the whole connection, as shown in Figure 17. To further compensate this, additional jumpers may be used to connect the initial jumper and the conductor as shown in the bottom left picture of Figure 17 and in Figure 18. This is an approach largely followed in Crete and Rhodes and it has proven a valuable precaution not only against hot spots but also as an added safety measure.

Fig. 17. Views of a severe hot spot.

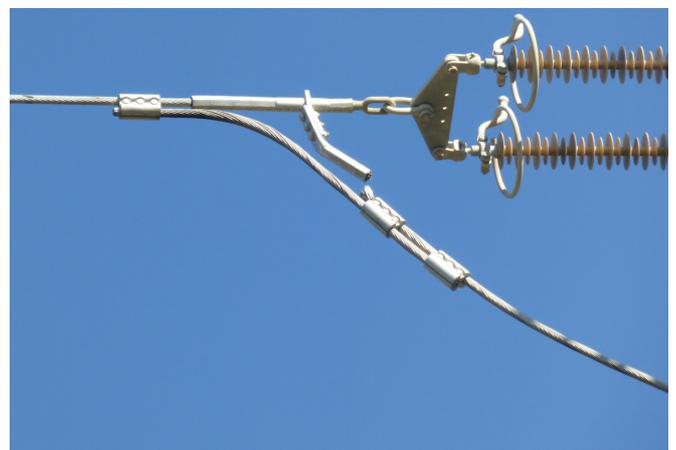
Fig. 18. An additional jumper saving the day.

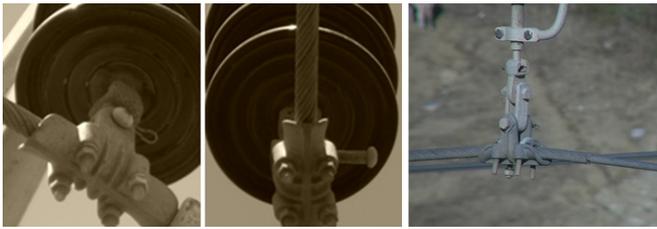
The linemen performing OTL inspections also check for missing or loose bolts, nuts, cotter pins etc. Such findings are not that rare and should be attributed mostly to vibrations, although other factors (e.g. under-tightening) may also play a role. Figure 19 shows instances from cotter pin and bolts about to fall off and a suspension clamp with three missing nuts out of a total of four. Such issues may not be easily spotted during ground inspections due to their nature and also the effect of the sun (a sepia filter had to be used in order to get the first two pictures of Figure 19). Such issues were usually dealt with upon their discovery in case of climbing inspections and thus, especially in the past when climbing inspections were the cannon, were under-recorded, as they were considered minor issues that are dealt with during inspection. Broken conductor strands are also an issue, and may be the result of vandalism (Figure 20) or of conductor swinging/vibrations (Figure 21). The latter is specifically important in case of junctions as the

Fig. 19. Missing and loosened cotter pins, bolts and nuts.

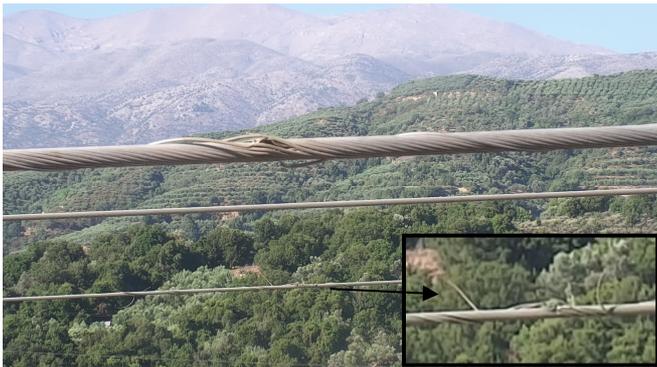
Fig. 20. Broken conductor strands due to vandalism.

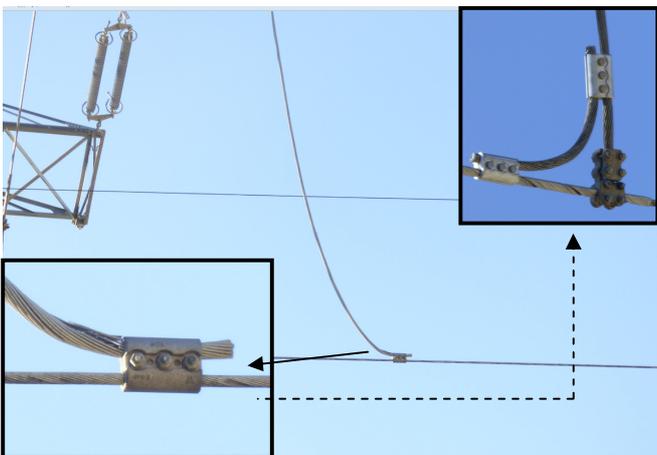
ones found in various locations in Crete, in combination with the effect of wind (Figure 21).

Fig. 21. Broken conductor strands and the improved arrangement at the junction outside the Agia Varvara Substation (the station was constructed as a connection point of a wind farm, an obvious hint that the location is subjected to strong and frequent winds).
