Theoretical and Experimental Investigations on 20 Inches Threaded Casing Connections Failure under Field Conditions

Abstract-This paper brings forward the results of theoretical and experimental investigations performed to determine the causes that led to the failure of 20 inches threaded casing connections during the tubing of the Lupşa Sat No. 1 oil well, Romania. The failure occurred due to the breakout of the threaded casing connections assembled in the factory. In order to establish the main causes of failure, theoretical investigations were taken into consideration to highlight the influence of the thread element errors on the correct make-up casing pin-coupling (box) conditions and to the axial tensile strength of the threaded casing connection. In addition, experimental investigations were performed on the failure casing connections, consisted of measuring the dimensional characteristics of the thread elements to determine the performance and monitor the technical condition of the tubular material used in the petroleum industry.

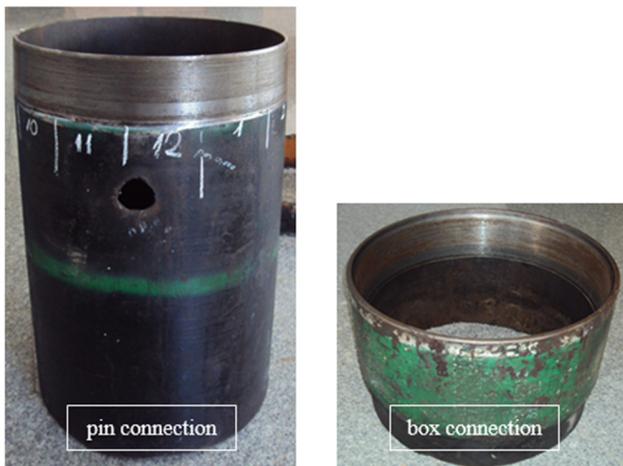
Fig. 4. Analyzed casing connection.

As a result of the visual examinations it was found that there were no traces of thread deterioration to highlight the fact that the casing has been jump-out from the box, but there were only slightly traces of damage by bumping or galling. Investigation was performed in order to explain the causes of breakout of the casing connections (factory assembled). All the submitted documents for casing connections involved in the event were studied regarding the technical manufacturing conditions and the accident's occurrence conditions. Also, experimental research and analysis were performed in the laboratories of the Petroleum-Gas University of Ploiesti for determining the mechanical characteristics of the material, its chemical composition and all the elements of the pin and box casing connection were measured. In order to establish the casing material, tests were performed on specimens taken from the failed casing connection and the obtained results confirmed the fact that the material used for manufacturing correspond to grade J55, according to API Specification 5CT [12].

The dimensional characteristics of the thread elements were determined on the two elements of the casing connection (Figure 4), made available by the beneficiary. Thread element measurement was performed according to [7] using the Gagemaker verification tools and procedures (Figure 5), and instruments for thread profile verification STARRETT HF600 and ALLEN # 3285 (Figure 6). Thus, the dimensions of the thread elements for casing connection (pin and box), provided with tolerances in the API 5B Spec standard (thread profile, thread height, thread lead, thread taper, pitch diameter and ovality, total thread length between the end of pipe to vanish point, and ineffective thread length), were measured.

- The profile of the two threads (pin and box), examined in the areas where there was no evidence of degradation, does not present any shape deviations. The thread root, the thread crest, and the thread flank angle correspond to API 8 – Round standardized thread values.

- The pin and box threads have the appropriate heights, within the tolerance specified in API Specification 5B.
- The values obtained for thread lead errors per inch, thread taper, total thread length L_4 , and effective thread length L_2 , determined for both casing connection elements (pin and box), fall within the limits specified in API Specification 5B.

- Verification of the pitch diameter revealed that the differences between the standardized value and the average values of the pitch diameter, determined in the case of the box thread, are very small and fall within the range of $-0.31 \div 0.33\text{mm}$ ($-0.012 \div 0.013\text{in}$), and in the case of the pin thread, they have negative values, ranging in the range $-2.31 \div -0.31\text{mm}$ ($-0.091 \div -0.012\text{in}$), with a maximum value of -2.7178mm .

- The thread ovality values determined after the box measurements were found to be within the limits recommended by the API 8 - Short round thread, but the ovality values obtained for the pin thread exceeds the recommended limits (2.464mm from the recommended maximum 1.524mm).

As a conclusion, the probable cause of the breakout casing connection (factory assembled) is represented by make-up connection with a make-up torque value insufficient to assure the standard jump-out strength, due to the deviations to pitch diameter and ovality. Although the breakout casing connection (factory assembled) did not lead to a serious failure, the event highlights the need to pay extra attention to the threading operations and especially to the control of threaded connection and make-up conditions. Also it is recommended to perform a risk management evaluation [15].

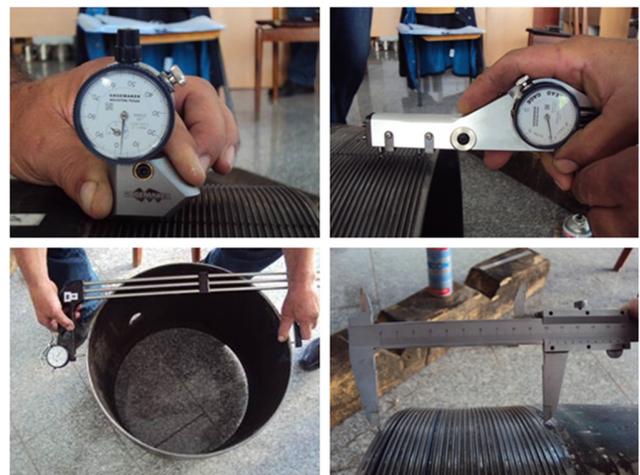
Fig. 7. Images during the performed thread geometry measurements.

Figure 7 shows photographs taken during the thread geometry measurements. Taking into consideration all the theoretical analyses and experimental investigations performed on the casing connection, we proceeded to interpret the causes of the failure of the surface casing by breakout the threaded connections (factory assembled).
