# Fracture Analysis of a Cycloidal Gearbox as a Yaw Drive on a Wind Turbine

**Jairo Aparecido Martins**

**Estaner Claro Romao**

## ABSTRACT

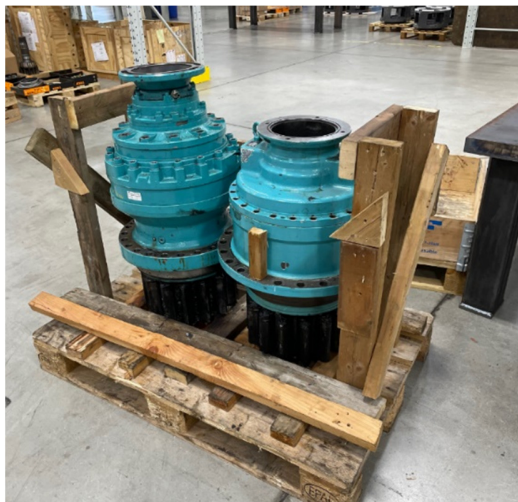
The gearbox was received on a pallet with transversal wood bars to protect it against impacts (Figure 1). A total of 4 gearboxes were delivered, but only one of them passed through analysis. The electrical motor was not included in the pallet. From the outside, there is no damage in the housing, oil leakage, plugs missing, or screws. Furthermore, the output pinion does not contain corrosion or damage to the gear teeth.

Fig. 1. Yaw gearboxes as received.

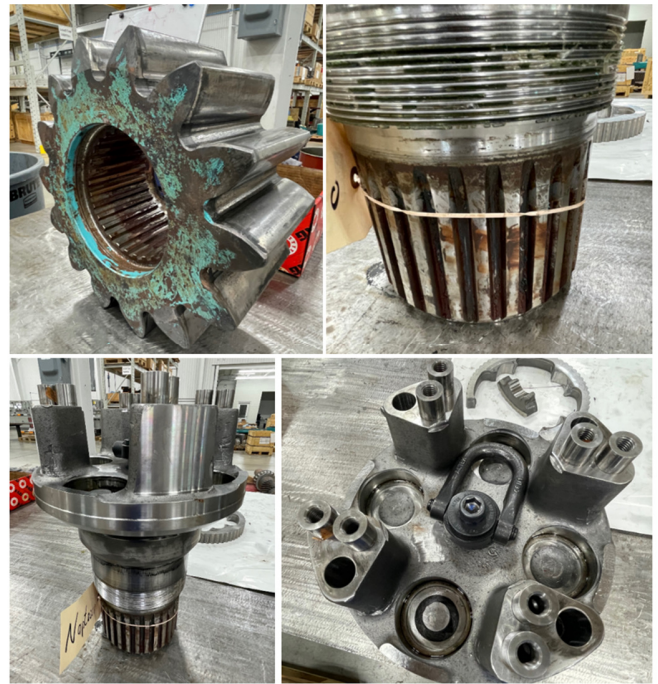
Figure 2 illustrates the disassembled output gear, the main shaft, and its spline. It can be seen that although the output gear is not damaged, it has corrosion on the internal spline. The body of the main shaft shows profound dents and small scratches certainly produced during the internal collision of pieces of metal. As a common knowledge in the cycloidal gearbox, the cycloidal discs are those that transfer the highest torque, therefore, the ones more likely to have high stresses. Another checking point was the condition of the spur gears in the first stage (Figure 3). They are in good condition, with no marks, high wearing, or deep corrosion identified.

Fig. 2. Output gear, shaft spline with its upper base.

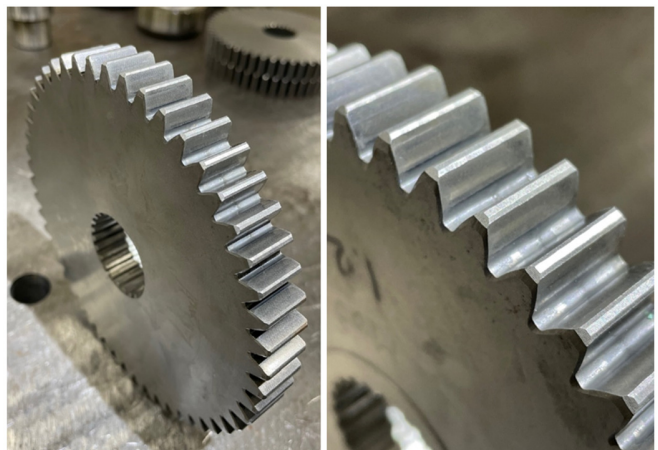
Fig. 3. Stage 1 Spur gears and teeth condition.

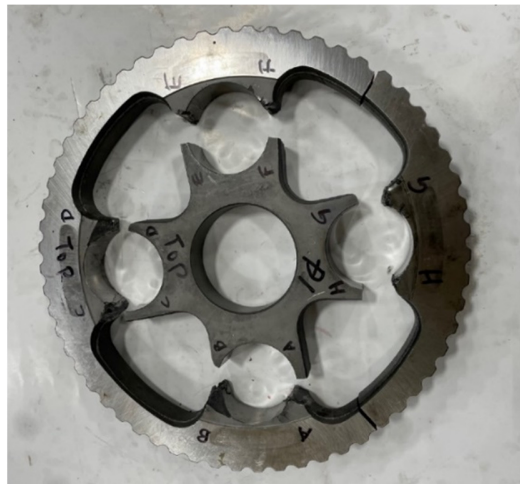
The disassembling process continued, and the second stage was reached, where a major collapse occurred. To better map the failure, the cycloidal disc legs were labeled with letters from A to H to have a better understanding of the fracture mechanism of each fractured location, and further on to analyze them as pieces of the whole part (Figure 4).

Fig. 4. Overview of the cycloidal disc.

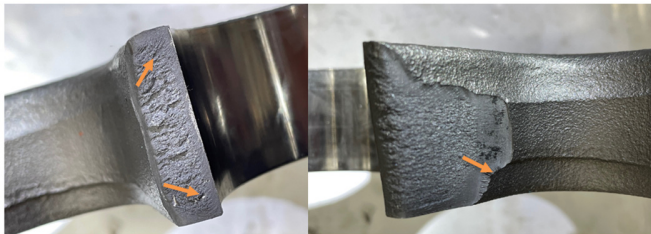
Figure 5 shows that legs A and B had, as indicated by arrows, two crack nucleation spots at leg A were verified as well as a crack starting on the casting at Leg B at the right downside of the figure. As a highlight, between legs, A and B, the bearing bores are located. Figure 6 on the left (Leg C) shows a final fracture on the cross-section, which differs from the right side (Leg D) where a crack initiated on the opposite side of the bearing bore (corner) but moved towards it and another at the bearing bore surface.

Fig. 5. Leg A (left) and Leg B (right) – arrows indicate crack nucleation.

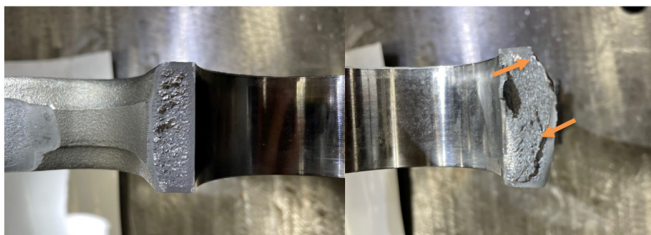
Fig. 6. Leg C (left) and D (right) – arrows indicate crack nucleation spots.

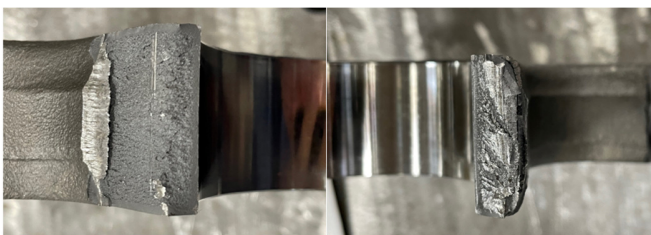
Fig. 7. Leg E (left) and F (right).

On the left side of Figure 7 (Leg E) a double layer of material is verified which suggests an underlayer, where a crack began, and an abrupt detachment happened before the final failure. On the right, (Leg F) an intense fretting after the final fracture is suggested [29]. The arrow in the left of Figure 8 (Leg G) reveals a crack initiating at the corner of the cross-section at the casting side of the part, Figure 8 (right – Leg H) shows at least two points of crack nucleation with a perceptible distance between the beach marks, probably because of due to a more intense strain cycling close to the part collapse [25].

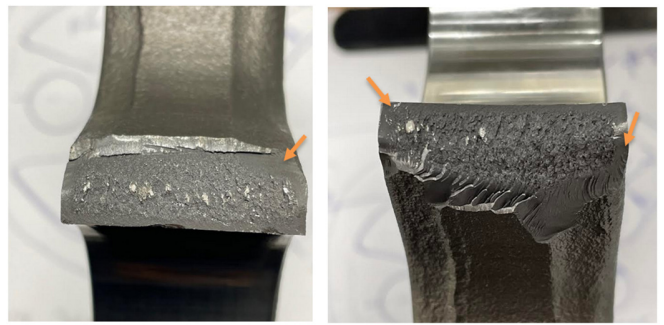
Fig. 8. Leg G (left) and H (right)- arrows indicate cracks in nucleation spots.

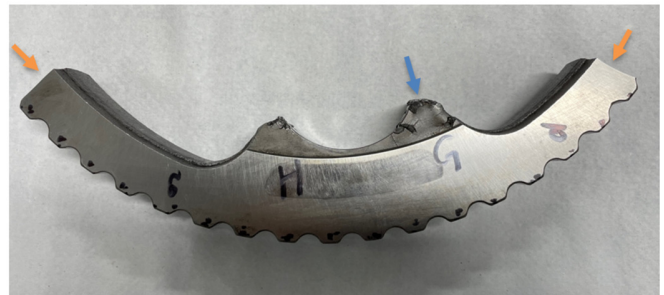
Fig. 9. Broken part of the cycloidal disc showing multiple cracks – arrows on both sides indicate the regions verified in Figure 11, the center arrow pointing to G shows multiple cracks.

The central arrow in Figure 9 reveals multiple cracks on the Leg G surface and large deformations, which indicate a high level of stress in multiple directions, suggesting torsional loading as well as radial and axial ones, most likely due to the high instability throughout the fracture process. Figure 10 shows the outer fracture of the cycloidal disc close to Legs G and H, as indicated in Figure 9 by arrows on both sides. Leg G on the left side, shows the crack initiating on the external side of the bearing bore (casting), while in Leg H the crack started at the external diameter of the cycloidal disc.

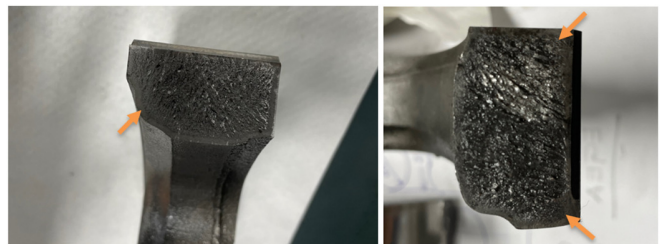
Fig. 10. Leg G (left) and Leg H (right) – arrows show the crack nucleation spots.

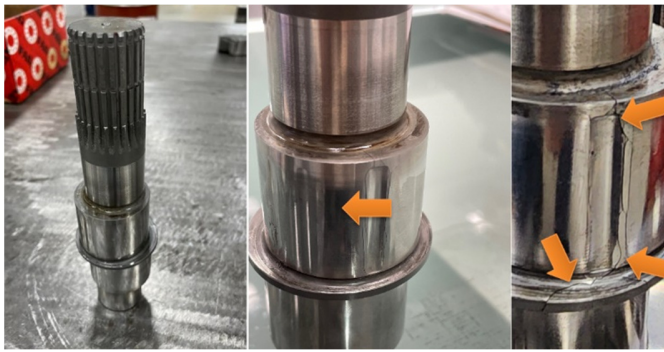
The crankshafts were analyzed in terms of major deformations. All shafts show deep plastic deformation on the bearing region. Those deformations are due to high pressure by the bearing rolls on the shaft surface during failure (Figure 11). The bearings were also evaluated and visually checked for dents, marks, or corrosion. Although they are in good condition, the regular procedure for every service is to replace them due to clearance uncertainty (Figure 12).

Fig. 11. Crankshaft.

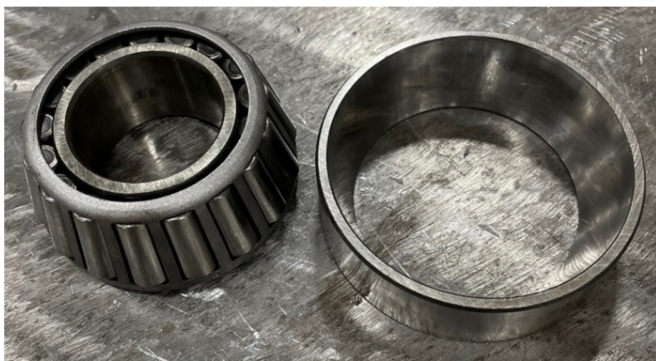
Fig. 12. Bearing that drives the cycloidal disc.

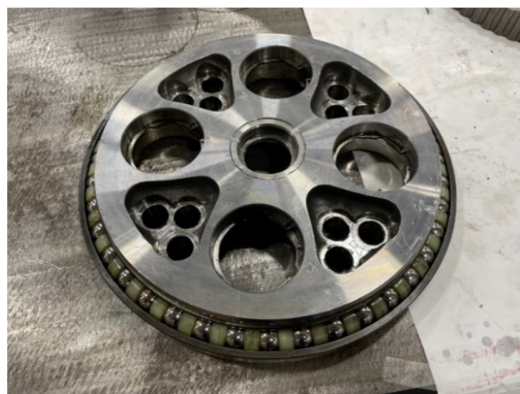
The output flange in Figure 13 shows a solid part with no deformations, only a few expected scratches during operation and disassembling.

Fig. 13. Output flange.

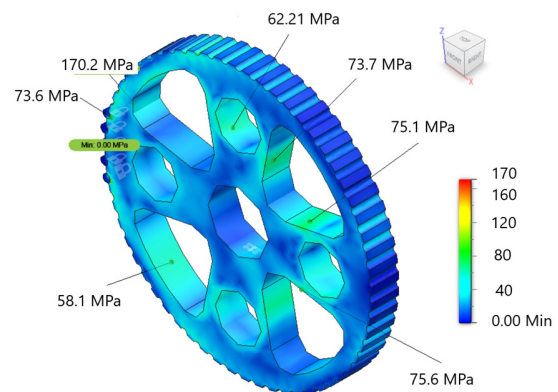
Figure 15 presents the regions with the higher stresses located at the external radius in the groove close to the disc external diameter (170.2 MPa) and regions on the same profile but now on the flat surface that neighbors the bearing bore (75.1 MPa). Those regions on the cycloidal disc coincide with the cracks-initiated regions at the part. However, the stress level is expressively low when compared to the hardened material's mechanical strength [25].

Fig. 15. Output results from the FEM calculations.

The obtained values couldn't be reached during the whole yaw drive lifespan, which suggests abnormalities on the cycloidal disc during operation. As a reference, the material 35CrMo might have a stress amplitude of 550 MPa for an infinite fatigue life ( $>10^6$  cycles) – based on the S-N curve – which is much higher than the 170.2 MPa calculated via FEM.
