# Damage to Natural Gas Distribution Steel Pipelines caused by Rigid Bodies resulting from the Excavation of Laying Trenches

## ABSTRACT

The present paper focuses on analyzing the occurrence of defects such as dents and local deformations by laboratory simulations of a real case of a defect detected on a natural gas distribution pipeline laid at a depth of approximately 0.6 m. The defect is caused by a river stone which due to the compression forces, damages the pipe to the point of cracking. In the laboratory, the simulation was carried out on a steel pipe insulated with extruded polyethylene which was acted upon by a mandrel made of duralumin. The purpose of the tests is to determine the maximum values at which the pipe material fractures. It was found that the fracture of the pipes when there are rigid bodies in the protective layer of sand is accelerated by the sand existing between them and the pipe and by the change in the properties of the steel the pipes are made of when they are kept in water.

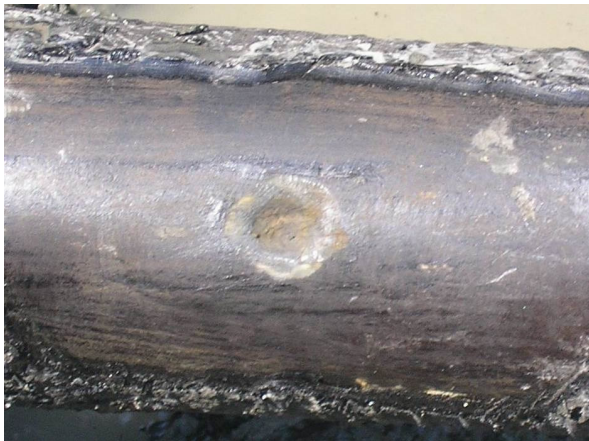
Starting from the defect shown in Figure 1 detected on the distribution network of pipelines in the Municipality of Sibiu, which occurred due to the existence of a river stone on the upper surface of the pipe, most likely resulting from the excavation of the laying trench and the inadequate depth of the

Fig. 1. Defects as local deformations detected on the pipelines.

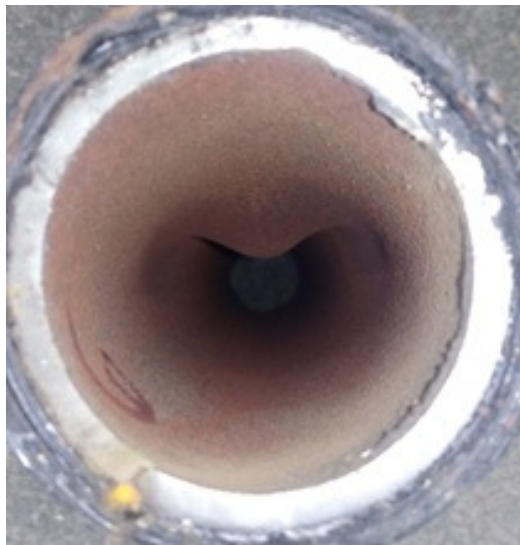
As can be seen, the pipe was subjected to different compressive forces from the testing machine, thus determining the maximum values in the moment of fracture (Figure 6) of the pipe material under the influence of compressive forces [8, 9]. The obtained data are shown in Table I. Regarding these data, it should be taken into account that it is impossible to keep the machine under constant load for more than 2 min and for this reason, the compression time at maximum force value was set at 2 min maximum, enough to read the compression values at the time of the pipe fracture [10, 11].

Fig. 6. Fracture of the pipe material.

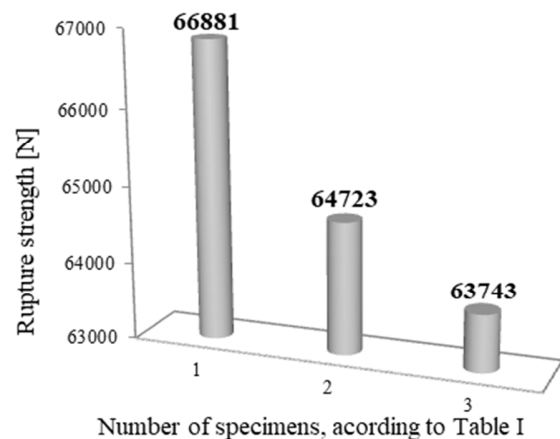
Analyzing the shown graphs and making a comparison between the different environments of the natural gas distribution networks, we conclude that the rupture strength of the pipe material is superior when the pipelines are kept in the atmospheric environment and decreases significantly when the samples are kept in sand or water. We consider that, in the case of pipes kept in sand, this is due to its granulation and hardness, and when they are kept in water, it is because water changes the properties of the steel the pipe is made of.

We can thus conclude that the fracture of the pipes in the situation when there are rigid bodies in the protective layer of sand is accelerated by the sand existing between them and the pipe and by the change in the properties of the steel the pipes are made of, when they are kept in water (see Figure 7). The next step in our study will be to analyze and simulate this case using the finite element method to determinate the behavior of the pipe subjected to similar loads.

Fig. 7. Rupture strength of the pipe depending on the environment.
