Effect on Fatigue Behavior of Connecting Rod in Gasoline Engine

This article reports the failure analysis of a connecting rod that is broken into 3 pieces and is used in the gasoline engine of a sedan. The connecting rod is made of JIS-S50C medium alloyed steel. Fractography was performed to characterize the failure mode on the fracture surface of this connecting rod through the examination of the macroscopic and microscopic morphologies of the fracture surface, chemical composition, metallographic analysis, mechanical properties of the material, and numerical simulation. The fracture surface of this connecting rod is caused by fatigue, which was the dominant mechanism of failure. This type of crack is indicative of shear failure in the ductile fracture mode, whereas no abnormalities were found in the composite elements of the connecting rod. The microstructure is composed of perlite-ferrite. The results of the numerical simulation and the calculated crushing stress (s_c) were compared and were found to be in accordance and within the acceptable values.

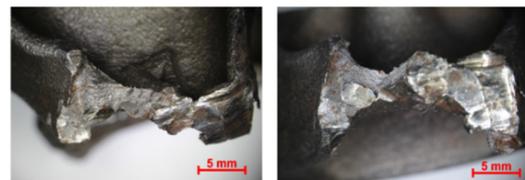
The visual examination of the failed connecting rod in Figure 3 indicates that there are 3 damaged parts. The first connecting rod has a broken surface and the entire surface is abrasive, as shown in Figure 4. The second connecting rod has a relatively intact surface, as noticed in Figure 5, which displays the starting point of the crack origin appearing at multiple points. The crack slowly expands through the fatigue zone, or the damaged area by periodic loading. During the slow crack propagation there are variations in the applied force, affecting the crack growth rate. When the crack expands for a while, the material has little space to support the force and causes an area to receive the final overload. In that area, it was found that most of the cracks that expanded were macroscopically characterized as brittle fractures. In the third connecting rod, the fracture surface is partially rubbed and there are signs of broken surface, as observed in Figure 6 [8].

Fig. 6. Broken surface of the third connecting rod.

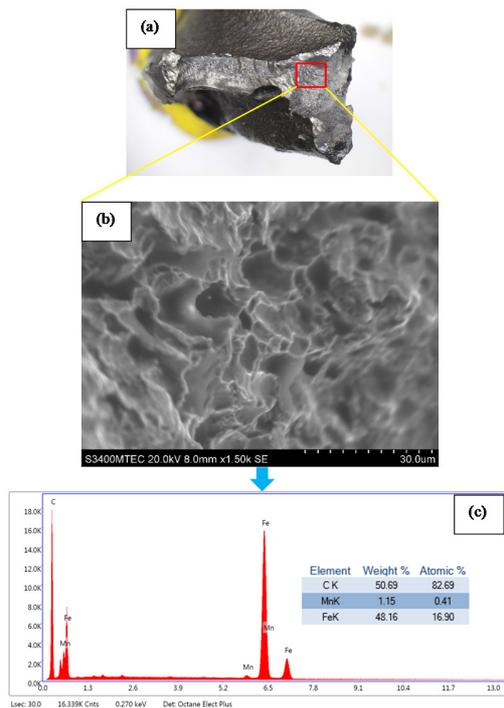
Examining the fracture in the second failed connecting rod by using a scanning electron microscope, a close-up image of the final overload fracture in the connecting rod is detected in Figure 7(a). Dimples are clearly apparent from the same point in Figure 7(b) when it is magnified. This structure is characteristic of a fracture followed on by uniaxial tensile failure. Each dimple is one half of a micro void formed during the fracture process and is subsequently cracked separately. In case of fracture, dimples appear on the 45-degree shear lip. The ductile fracture form, resulting from the shear behavior, is elongated or C-shaped, and this parabolic shape may be characteristic of shear failure [11, 14]. Figure 7(c) depicts a surface layer examination of the same area. SEM was deployed to analyze the chemical composition of the fracture surfaces of the failed connecting rod for inclusions using energy dispersive spectroscopy (EDS). The line of scan discloses that most elements within the standard weight percentage of steel material are iron (Fe), carbon (C), and manganese (Mn). Connecting rod alloy composition is confirmed to be medium alloy S50C with no abnormalities.

Fig. 7. (a) The final overload fracture. (b) Dimples at a magnification of 1.5kx. 30 μ m. (c) The EDS results on the final overload zone from the same areas.

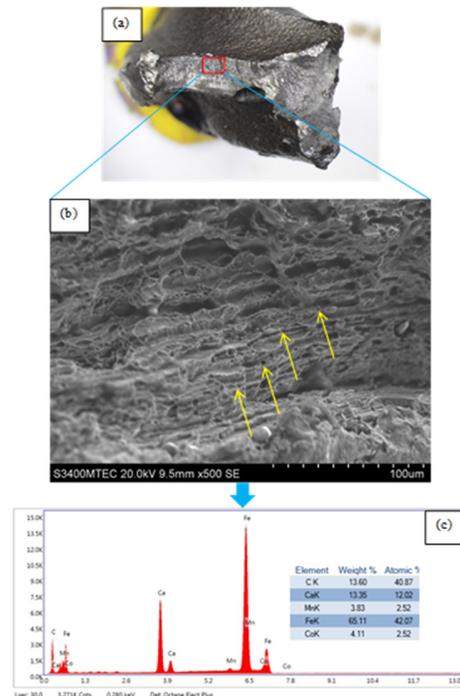
The photograph at the surface region in Figure 8 (a) is a magnified image of the surface fracture area of the connecting rod. An enlarged section exhibiting fatigue striations and revealing the displacement direction between atoms, with fatigue striations in each stress period or each stress cycle acting on the specimen is observed in Figure 8 (b). These lines can only be seen through examination by a high-powered microscope. Figure 8 (c) depicts a surface layer examination of the same area. SEM was used to analyze the chemical composition of the fracture surfaces of the failed connecting rod for inclusions implementing EDS. The line of scan reveals that most elements within the standard percentage by weight of steel material are iron (Fe), carbon (C), Calcium (Ca), manganese (Mn) and (Co) Cobalt. The connecting rod alloy composition was confirmed to be medium alloy S50C with no abnormalities.

Fig. 8. (a) SEM micrograph showing 1x. (b) Magnification of the visible fracture area demonstrating fatigue striations and the direction of motion between dislocations of atoms. (c) EDS results on the fracture zone from the same areas.

A fractography examination on the fracture surface of the connecting rod was conducted. The beginning of the crack origins that occur in multiple points are then propagated to the instant fracture zone, attributed to the high intensity of the stress exerted on the workpiece. This led to a substantial final overload zone. The difference between the results of the numerical simulation and the calculation of the stress value is 8%, which is within the acceptable value. Also, the calculated stress of the material is 702 MPa. The calculated stress value is

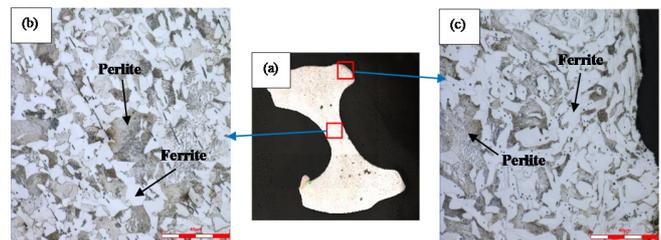
Metallographic examinations were also performed. A transverse cross section of the failed connecting rod was cold mounted using epoxy resin, then ground using emery paper (down to #1200 grit) and polished with 1 μ m diamond paste. The microstructure was etched by using 2% nital solution (2 ml HNO₃ + 100 ml DI water) and examined using light optical microscope (OM). Figure 9(a) shows a low magnification image (1x) with two telescopes at the surface and core of the connecting rod. The central axis in Figure 9(b) contains a perlite-ferrite microstructure and found manganese sulfite inserted in the ground metal. The cross-section and microstructure of the outer surface showed pearlite-ferrite in Figure 9(c).

Fig. 9. Microstructure of the connecting rod (a) Photograph taken at low power 1x. (b) Photograph of the microstructure center consisting of pearlite-ferrite. (c) Photograph of the microstructure surface with Pearlite-ferrite composition.

This case study suggests that the surface hardening process should be improved so that the outer surface of the connecting rod has a martensite microstructure to enhance strength.

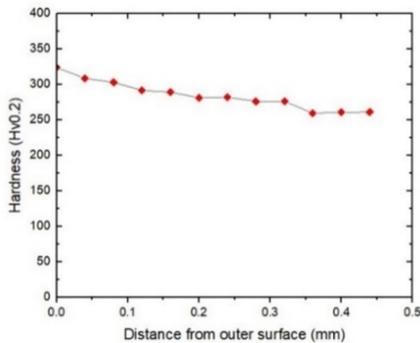
A connecting rod hardness testing by Vickers hardness measurement using an Anton Paar hardness tester: MHT-10 was performed. The cross-sectional hardness measurement employs a pyramid-shaped diamond indenter with a square base with an angle of 136° starting from the outer surface of the connecting rod into the core of the connecting rod at all 12 points. The results of the hardness measurement were obtained. As portrayed in Figure 10, the maximum hardness at the connecting rod surface is 324 HV. The hardness decreases along the radial direction (0.45 mm) until the minimum hardness at the center of the shaft is 261 HV [4, 14].

Fig. 10. Hardness graph measured from the outer surface edge to the center of the connecting rod.

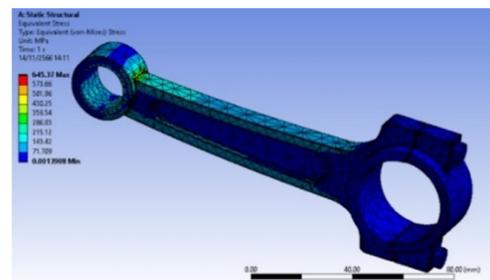
Fig. 13. Von mises stress values obtained from numerical simulations.

The calculated crushing stress (σ_c) was 702 MPa, and the numerical simulation results of Ansys Workbench were 645.37 MPa. The results differed by no more than 8%, which ensured

that the program was not compromised. The yield strength of the material is 415M Pa [16-25]. The calculated stress value is 1.69 times greater than the yield strength, which results in the final shaft fracture. In conclusion, if the stress is greater than the yield strength which the material can support, this is the cause of the connecting rod breaking [16-24].

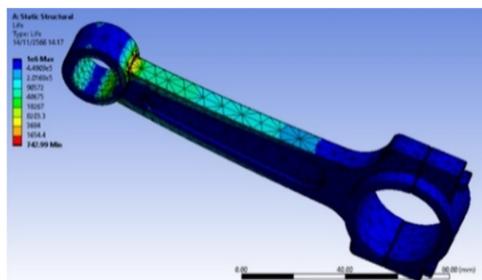
Fig. 15. Fatigue endurance limit values obtained from numerical simulations.

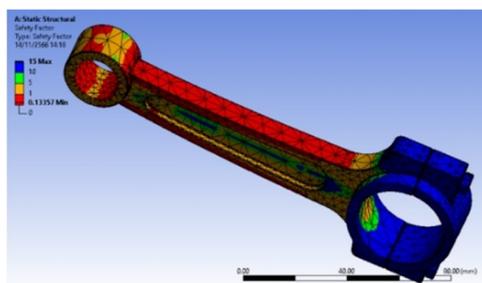
Fig. 16. Safety factor obtained from numerical simulations.
