Flexural Behavior of Reinforced RAC Beams Exposed to 1000°C Fire for 18 Hours

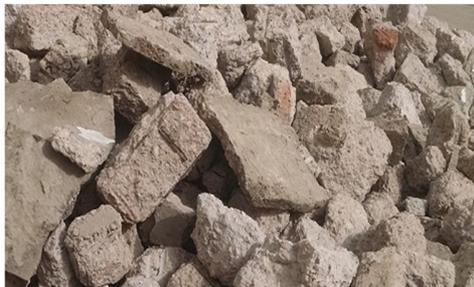
Fig. 1. Demolished concrete

The demolished concrete used in this research work was obtained from a demolished 50 year old school building in the shape of large blocks (Figure 1). These blocks were manually hammered to obtain aggregates of 25mm in size (Figure 2). The cracked particles were screened and separated carefully (Figure 3). Sieve analysis of both natural and recyclable aggregates was done to have well graded aggregates.

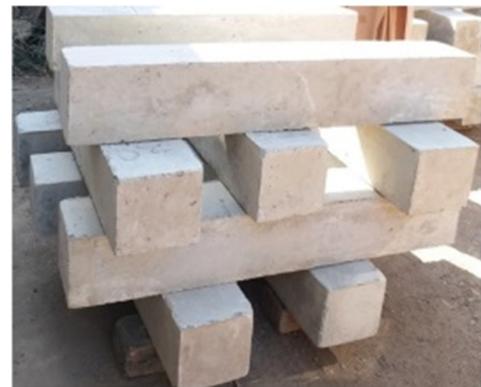
Fig. 4. Beam samples

As old mortar is attached with the demolished concrete and requires more water in the concrete mix to ensure workability, water absorption test of recyclable and natural coarse aggregates was done in standard fashion. The water absorption of natural coarse aggregates was obtained equal to 1.80% and that of recyclable aggregates was equal to 3.92%. Accordingly, the water demand in concrete mix was adjusted. Twenty four reinforced concrete beams were prepared using 1:2:4 (normal mix) and 1:1.5:3 (rich mix). In each concrete mix 50% beams were cast with all-natural coarse aggregates and 50% with equal proportion of the natural and recyclable aggregates following the conclusions of [3, 12]. To reinforce the beams, 2#4 deformed steel bars were used both in tension and compression zones along with #3 bars as shear reinforcement at 150mm center to center along the beam length. The size of all beams was taken equal to 900mm×150mm×150mm. The prepared beams (Figure 4) were cured for 28 days by fully immersing in water, and were air-dried for 24 hours. All the beams were then exposed to fire for 18 hours in a purpose made oven (Figure 5) at 1000°C. Burnable wood was used as the source of fire. It was observed that 1 hour was required to reach the temperature of 1000°C, which was then maintained for the required duration of time. After the elapse of fire duration, the fire source was cut off and beams were left in the oven for 24 hours to avoid sudden attack of atmospheric moisture.

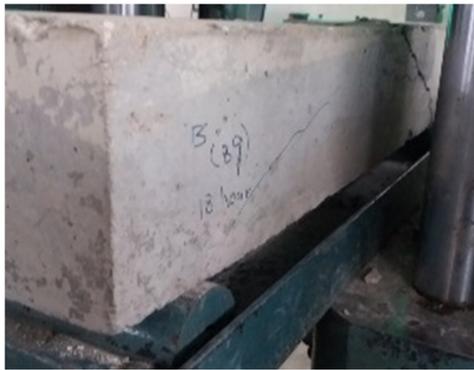
Fig. 6. Beam testing

Finally, all the beams were tested in a universal testing machine under central point load in accordance with [11] (Figure 6) until failure. During the testing load, deflection and cracking were monitored at regular intervals. The flexural capacity of the beams was then computed using the numerical expression given in [11]. The obtained results for the beams cast with all-natural coarse aggregates (G1) and 50% recyclable aggregates (G2), with normal mix are given in Tables I and II respectively. Similarly, Table III lists the test results of reinforced concrete beams cast with rich mix and all-natural coarse aggregates (G3) while the results of reinforced concrete beams cast with rich mix and equal proportion of natural and recyclable aggregates (G4) are given in Table IV. All beams were exposed to fire for 18 hours.

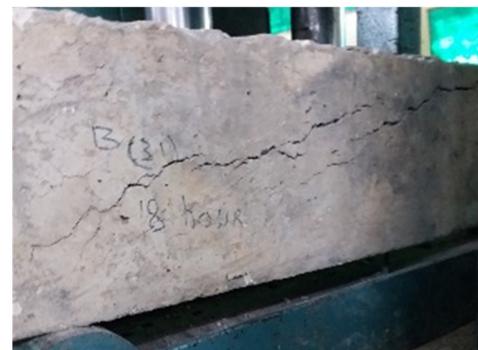
Fig. 13. Cracking in beams

decrease as peak load. The results of the deflection showed increase for both normal and rich mix concrete beams. Normal mix beams with recycled aggregates exhibited 17.61% increase in comparison to their counterpart cast with all-natural aggregates. Whereas, mix concrete beams with recycled aggregates recorded equal increase to 9.48%. In comparison to ACI-318 specified approximate allowable deflection values, the deflection at failure in normal mix beams tripled and in rich mix beams doubled. Therefore, rich mix concrete beams showed better performance regarding deflection in comparison to normal mix reinforced concrete beams. Cracks and cracking pattern at failure were also observed during testing. Due to fire exposure, several surface cracks were presented even before the start of the test, therefore it was difficult to monitor the first crack due to loading. Crack pattern after failure was observed as diagonal cracks from center towards supports or near to supports, with arching action in some of the specimens. Therefore, the failure mode of the beams was identified as shear failure (Figure 13).
