Performance of Segmental Post-Tensioned Concrete Beams Exposed to High Fire Temperature

Abstract—The present study illustrates observations, record accurate description and discussion about the behavior of twelve tested, simply supported, precast, prestressed, segmental, concrete beams with different segment numbers exposed to high fire temperatures of 300°C, 500°C, and 700°C. The test program included thermal tests by using a furnace manufactured for this purpose to expose to high burning temperature (fire flame) nine beams which were loaded with sustaining dead load throughout the burning process. The beams were divided into three groups depending on the precast segments number. All had an identical total length of 3150mm but each had different segment number (9, 7, and 5 segments), in other words, different segment lengths. To simulate genuine fire disasters, the nine beams were exposed to high-temperature flames for one hour along with the control specimens. The selected temperatures were 300°C (572°F), 500°C (932°F), and 700°C (1292°F) as recommended by the standard fire curve (ASTM-E119). The specimens were cooled gradually at ambient laboratory conditions. The performance o

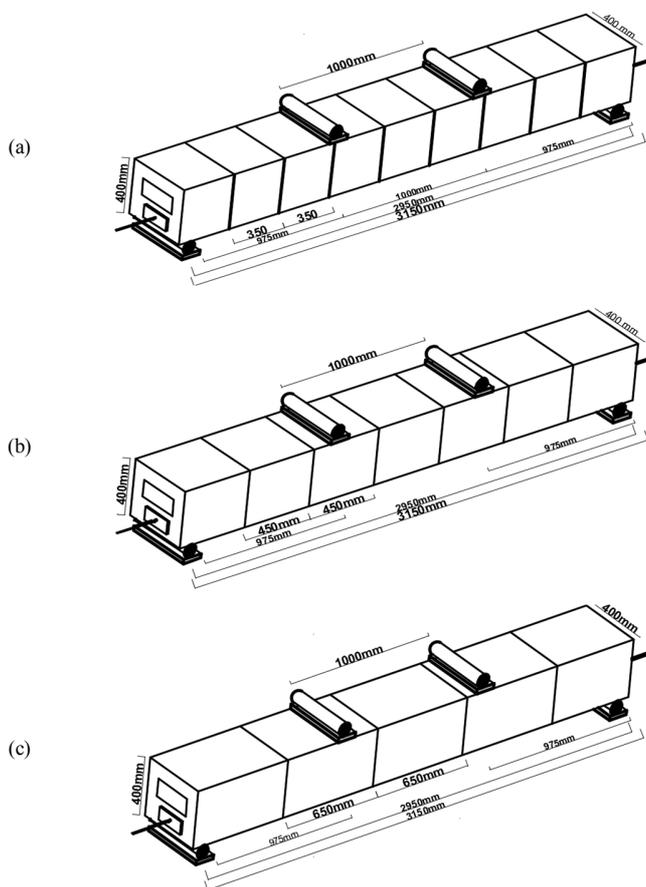
Fig.1. Schematic shape and dimensions of the tested SPC beams: (a) Group I, (b) Group II, (c) Group III

The experimental program consisted of twelve simply supported segmental prestressed concrete beams divided into three groups depending on the precast segments number. All the SPC beams were selected and designed with 3150, 400 and 400mm length, depth and width, respectively. The first group consisted of SPC beams with 9 segments (350mm segment length), the second group with 7 segments (450mm segment length), while the last group had 5 segments (630mm segment length). Figure 1 shows the schematic shape of the SPC beams for each group. Figure 2 demonstrates the details of the two opposite contact surfaces of reinforced concrete precast segments, which have been used to assemble the SPC beams, the first consisted projections as shear connectors (keys), in contrast the other consisted pits to engage with the projections.

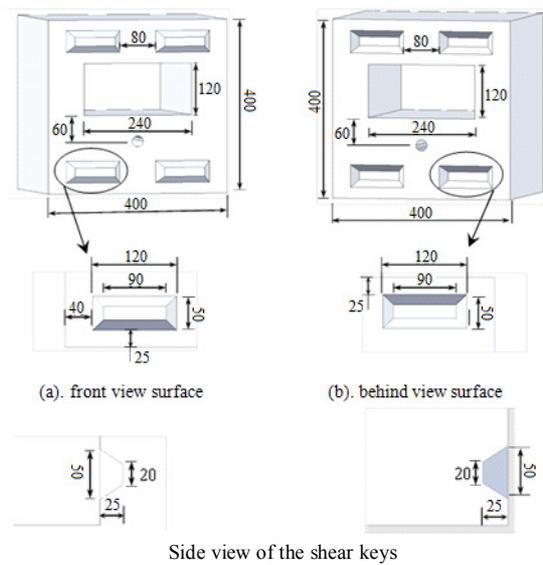
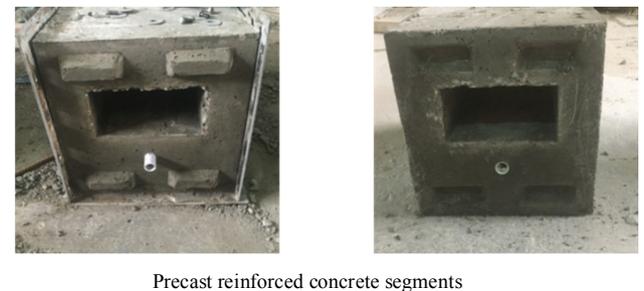
Fig. 2. Configuration of SPC beam segments (all dimensions in mm)

Precast reinforced concrete segments

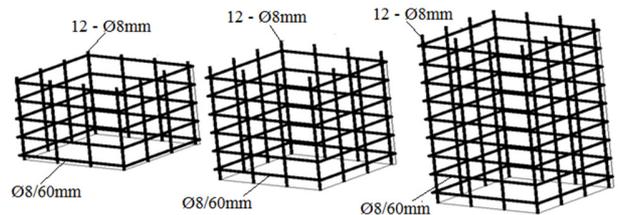
Fig. 3. Reinforcement details of segments for each group of the tested SPC beams

The reinforcement details for the three groups are illustrated in Figure 3. The deformed 8mm diameter bar of 486 and 640MPa, its yield stress and ultimate strength, were respectively used for the longitudinal and ties reinforcement.

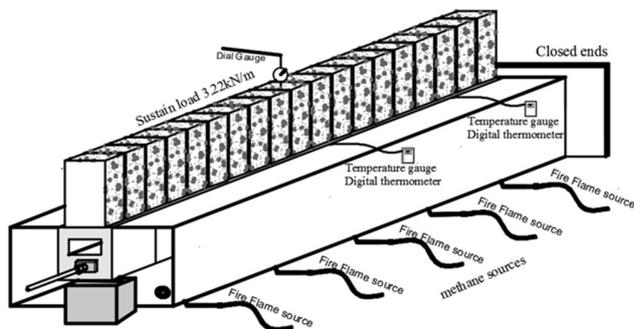
Fig. 4. Furnace schematic shape and burning process

700°C while applying uniformly a constant dead load of 3.22kN/m by using nineteen concrete blocks, 50kg each for similar exposure period of 1h after reaching the target temperature. After that, all beams were allowed to cool at ambient laboratory temperature. The burning stage comprised of positioning the SPC beams above their idealized simply supported ends, and the deflection due to the constant dead load and the camber change due to fire were measured using a dial gauge of 0.002mm/div sensitivity. The temperature was monitored by a digital thermometer reader with three thermocouple sensor wires type K (Nickel-Chromium/Nickel-Alumel), which can be used at temperatures up to 1100°C. The sensors were set at three points with equal distances in the top region between the furnace cover and the SPC beam at the mid, right and left of the top case of the furnace. The fire flame test procedure is illustrated in Figures 4 and 5.

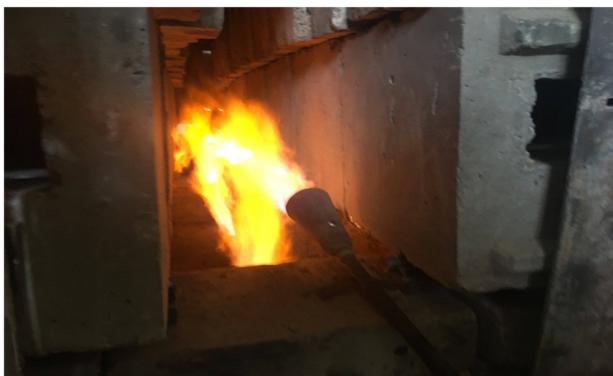
Fig. 5. Burning process

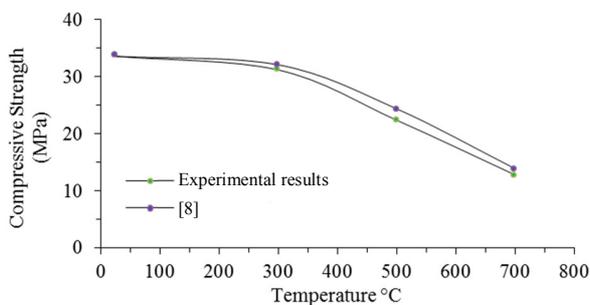
Fig. 6. Burning temperature versus compressive strength

The loss of strength was characteristically varying depending from the burning temperature. Up to 300°C, only a small portion of the original strength was lost, about 7%. Severe loss in the strength mostly happened within the range of 500-700°C burning temperature and was 33%-62%, respectively. The proposed equations [8] are compared in Table III with the test results. It is clear that there is a good agreement between the experimental results and the values given by the proposed equations. The compressive strength (Figure 6) exhibits a rapid decrease above 300°C, due to the dehydration of calcium hydroxide in the cement which begins when the temperature reaches about 400°C, generating more water vapor and also causing an additional significant reduction in the physical strength of the material [10]. The residual strength exhibits a rapid decrease above 300°C as shown in Figure 7.

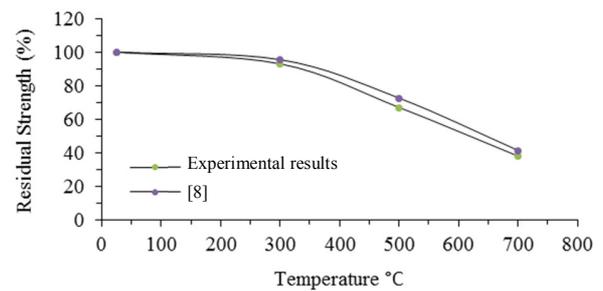
Fig. 7. Burning temperature versus residual strength

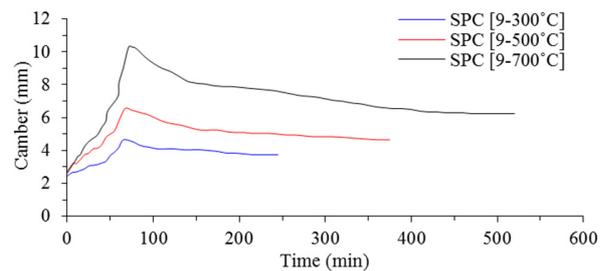
Fig. 8. Camber vs time for Group I beams at different temperatures

SPC beams of different segment lengths but identical in total length were subjected to fire test (Table I). Sustain load (3.22kN/m) was applied on the SPC beams simultaneously with the exposure to high temperature. The furnace temperature was applied as recommended by ASTM-E119. The beams passed through three stages within burning and cooling cycle. At the first stage, they reached the target temperature of 300°C, 500°C or 700°C. This took approximately 5, 7 and 12min respectively. Then, the temperature was stabilized for 1h. At the final and cooling stage, the SPC beams were cooled gradually by the ambient air (lab conditions). The effects of the three stages on the mid span camber for all beams are summarized in Table VI. Camber versus time history for the SPC beams of Groups I, II and III are shown in Figures 8, 9 and 10 respectively. These figures elucidate that, increasing burning temperature in the first and second stages lead to steep increase in SPC camber, while a gradual camber decreasing in the third stage occurs. The structure of the prestressed concrete beam exhibits upward curvature (camber) due to the eccentric prestressing force, which compressed the concrete at the lower zone (chord) of the prestressing force position and stretching

the upper concrete zone (chord). The fire was positioned at the base of the furnace towards the lower face of the SPC beam, in other words, exposing a concrete beam to high temperature under sustain eccentric load led to increase in the deterioration in higher camber, despite applying external load. This denotes that the effect of temperature was more on concrete than on steel reinforcement. The structural response of beams exposure to burning can be grouped into three stages as mentioned before. In stage 1 (heating stage), concrete and strands are subject to very little degradation. The cambers in all SPC beams increase gradually and these cambers result from the generation of thermal strains caused by high thermal gradients that occur in the initial stage of fire exposure.

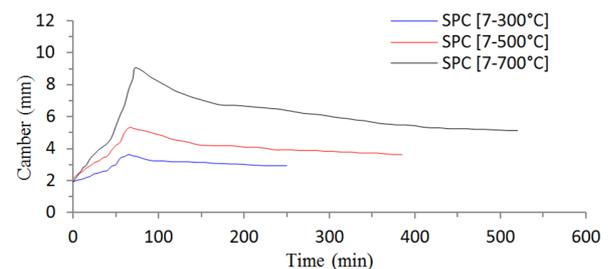
Fig. 9. Camber vs time for Group II beams at different temperatures

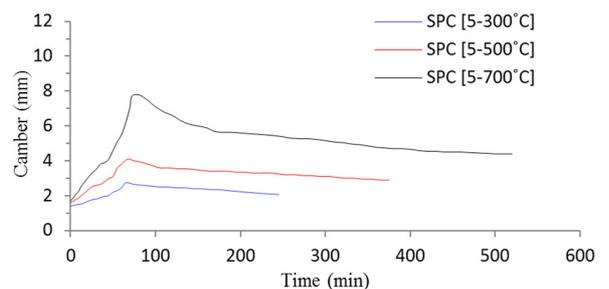
Fig. 10. Camber vs time for Group III beams at different temperatures

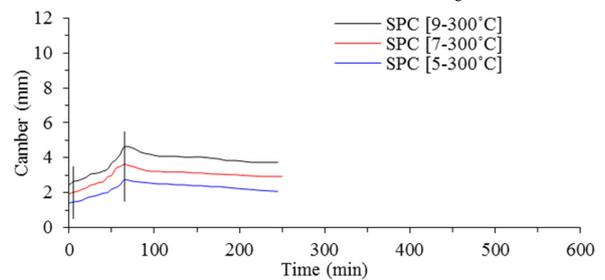
Fig. 11. Camber-time plot of SPC beams with different segment number during burning at 300°C and cooling cycle

At the end of the third stage the camber had a value higher than before burning. The ratio between the final camber after burning and the initial prestressing camber before burning is called the residual camber. The values of the residual camber are shown in Table VI. In general, decreasing camber of prestressed concrete beams is a sign of increasing losses in prestressing force. Increasing camber indicates that deterioration could happen in concrete strength whilst the prestressing force is not affected. Increased temperature had a bad effect on the residual camber, denoting that more deterioration occurred. The increased percentage in the residual camber for the beams of 9 segments (Group I) was 153%, 169%, and 236% for burned beams at 300°C, 500°C, and 700°C respectively compared to the initial camber before burning. For the beams of 7 (Group II) and 5 segments (Group III) it was 152%, 175% and 266%, and 150%, 182% and 253% for the same burning temperatures respectively. Comparing the effect with the number of segments shows that the camber increases with increasing number of segments. Exposing SPC beams composed of 7 and 5 segments to 300°C decreased the final camber at the end of burning and cooling cycle by 78% and 56% respectively. For SPC beams with 9 segments it was decreased by 80%, and 63% for Group II and 82% and 69% for Group III, at 500°C and 700°C respectively. Figures 11-13 show the camber difference of beams with different number of segments for the tested burning temperatures.

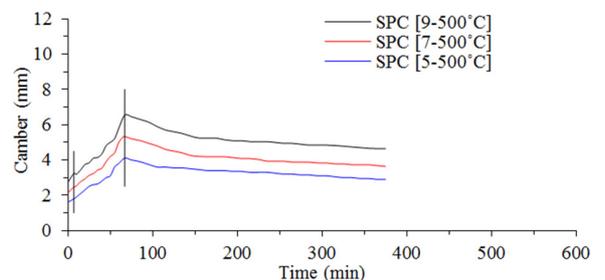
Fig. 12. Camber-time plot of SPC beams with different segment number during burning at 500°C and cooling cycle

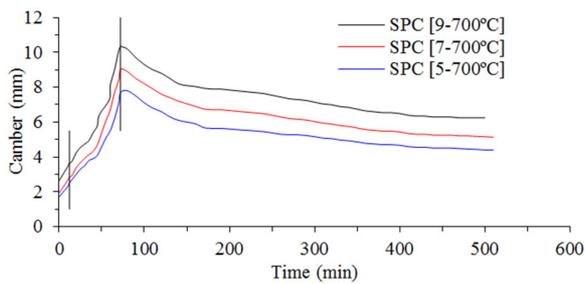
Fig. 13. Camber-time plot of SPC beams with different segment number during burning at 700°C and cooling cycle

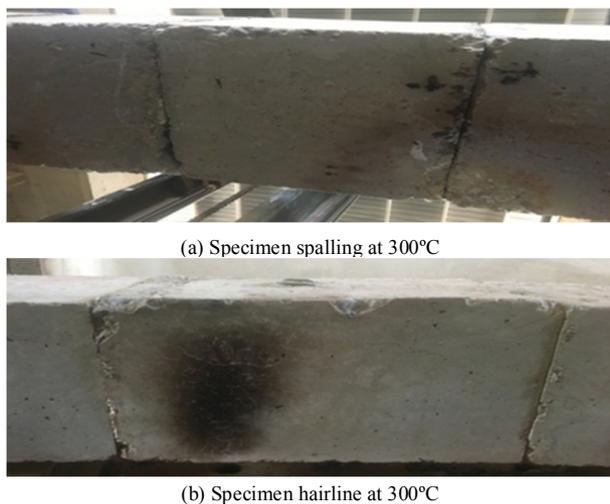
Fig. 14. Spalling and surface hairline cracks in surface (bottom fiber) of specimens near the fire at 300°C

During the burning test a distinct network of minor cracks occurred in SPC beams exposed to high temperature burning, however no main crack was testified. Cracking sounds were heard in some of the beams at around 15min after the start of the burning test that were mainly caused by spalling. At around 100°C, spalling started to appear, surface cracks were noticed and continued to develop until the final stage. Figures 14-16 show an appearance comparison of the beams after the exposure to fire. As mentioned before, the SPC beams were composed of different number of segments, and the burning nozzles were positioned at the lower base of the beams. These facts elucidate that due to the irregularity of fire distribution, deterioration was noticed at some segments more than others and that this difference had marginal effects on the distribution of hairline cracks on the beam surfaces. At 300°C the beams exhibited spalling cracks at some regions on the surface of the beam depth and at the edges near the fire source (Figure 14). Short cracks occurred in all the surfaces of the SPC beams and were concentrated in the joint positions between beam segments.

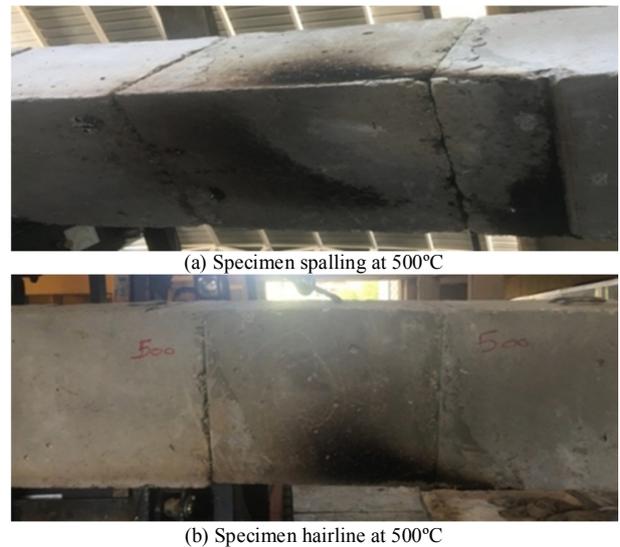
Fig. 15. Spalling and surface hairline cracks in surface (bottom fiber) of specimens near the fire at 500°C

At 500°C the SPC beams have suffered spalling at some regions in the surface and edges near to the fire source and surface hairline cracks were observed (Figure 15). It is clear

that the spalling effects at the bottom surface of the beams were deeper than those of specimens at 300°C and the surface hairline cracks were more and longer. Hairline cracks at this temperature went deeper between segments in the joint positions and occurred in the bottom surface at prestressing steel position. Naturally, the spalling was observed in the SPC beams burned at 700°C. The map-cracking and separation of concrete cover were more and deeper. After cooling, the spalling and the network of minor cracks in specimens increased as exhibited in Figure 16.

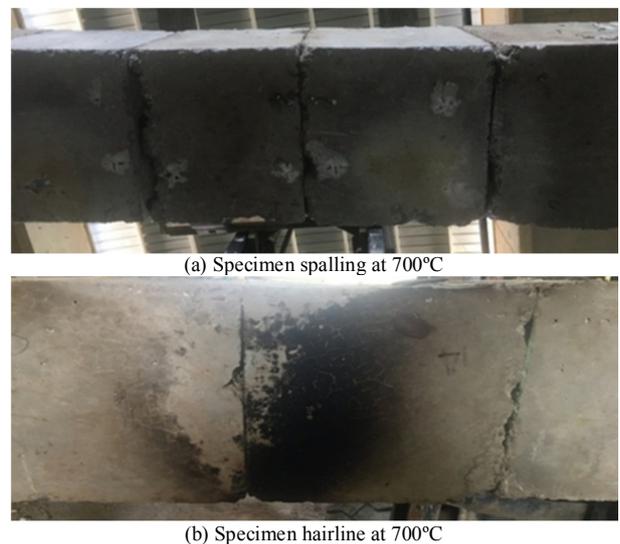
Fig. 16. Spalling and surface hairline cracks in surface (bottom fiber) of specimens near the fire at 300°C
