Seismic Evaluation of the RC Moment Frame Structure using the Shake Table

Abstract-This paper presents the findings of an experimental investigation on a reinforced concrete frame structure (ordinary moment resistant frame). The test model was subjected to lateral excitation employing the 1994 Northridge earthquake accelerogram. The reinforced concrete test model was fabricated in 1:3 reduced scale acquiring dimensional similarities. The utilized ingredient mix ratio was 1:1.65:1.75 and the water to binder ratio was 0.47. The dynamic characteristics (natural frequency and elastic viscous damping) were calculated using the free vibration record. Story shear, drift, and displacement profiles were drawn using multiple excitation records along with damage patterns and capacity curves. The natural frequency of 2.47Hz was calculated for the test specimen, which is equivalent to 1.41Hz for the prototype. Structural damping (elastic viscous) of 12.36% was calculated for the prototype.

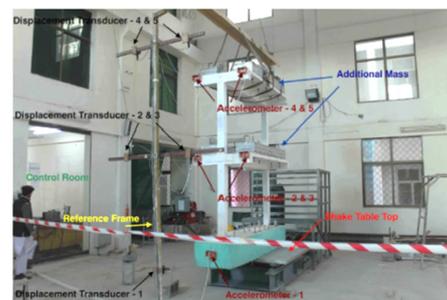
After anchoring the model on the shake table, transducers and accelerometers were installed at various locations. One accelerometer was installed at the center of the pad of the model and one at the right/left corner through the centerline of each slab. Similarly, displacement transducers were installed on the reference frame at an appropriate location. Details of instrumentation are shown in Figure 5.

Fig. 5. Instrumentation plan of the test specimen.

The test specimen was subjected to lateral loads on the shake table test available at the Earthquake Engineering Centre, University of Engineering and Technology, Peshawar, Pakistan as shown in Figure 5. Some recent studies on the response of an RC model subjected to lateral loads were also used [19, 24].

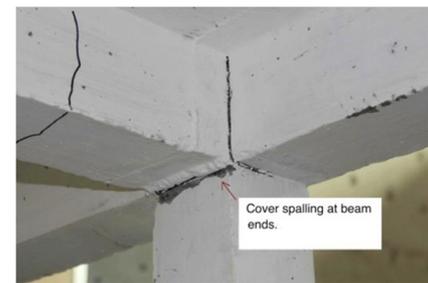
excitation, the existing cracks were further aggravated. Figures 22-24 show a few cracks and damages marked. Figure 25 shows the spalling of concrete from the peripheral beam-column joint along with minor damages.

Fig. 25. Spalling of concrete.
