Comparative Investigation of Pollution Accumulation and Natural Cleaning for Different HV Insulators

Abstract—High Voltage insulators are scattered throughout any HV network and a single insulator fault may cause an excessive outage. Reliability is a key issue for electric power systems and fault-free performance of insulators greatly reflects on the reliability of the system. Environmental influence is rather important for the optimum selection of outdoor insulators and, therefore, field measurements provide valuable information. Utilities perform such measurements in order to decide upon the location/route of new HV installations (substations, lines etc) and also to optimize the selection, maintenance and replacement of already installed insulators. A rather interesting case in Greek territory is the island of Crete, due to the coastal development of the network and the local weather conditions. The Greek utility has employed a variety of remedies to cope with the pollution problem. Following the positive feedback after the installation on certain tower in the past, a large project to replace all ceramic insulators with new polymer ones of hydrophobic surface is now in progress.

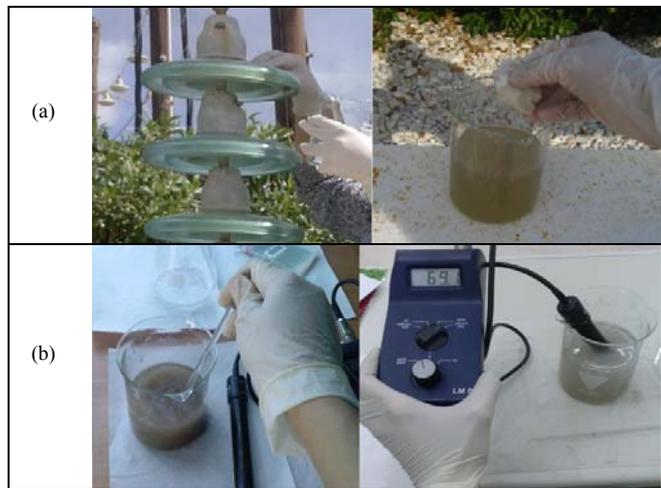
Fig. 6. (a) Collection of pollutants on site (b) Stirring and measuring the conductivity of the solution

One of the basic measurements proposed to assess a Site's Pollution Severity (SPS) class is the Equivalent Salt Deposit Density (ESDD) [6]. ESDD is given by the equivalent deposit of Sodium Chloride (mg/cm^2) on the surface area of an insulator, which has the same conductivity as that of the actual deposit dissolved in the same volume of water. It is determined by removing a pollution sample from the surface of a chosen insulator and then dissolving it in a known quantity of water. The conductivity of the solution, the volume as well as the temperature and the insulator surface area are considered to calculate the Equivalent Salt Deposit Density [3]. For these measurements, the pollutants deposited on the surface area of each insulator were wiped off with absorbent cotton, using 300 cm^3 of distilled water. Then, the resulting electric conductivity was measured by a conductivity meter, after sufficient stirring of the solution (Figure 6).

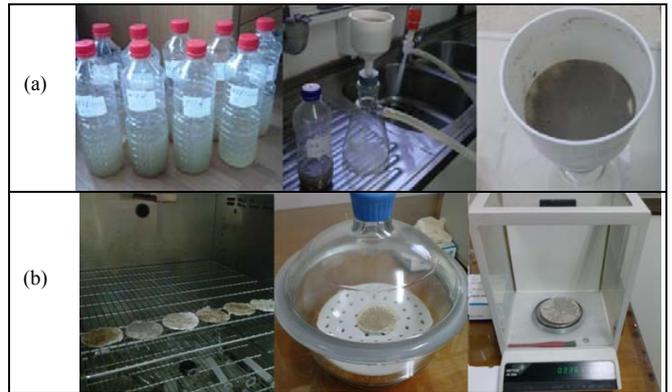
Fig. 7. (a) Solutions into labeled bottles, forced filtering with the help of a water vacuum pump and residuum on the filter paper (b) Filters in the drying oven, desiccator and precision scale

NSDD measurements can not be performed on site. For that reason the measurements were performed in HEDNO's Chemistry Lab in Iraklion. The solutions were carried to the Lab in labeled bottles and the filtering was forced through the use of a water vacuum pump to speed up the process. A drying oven was used for drying the filters and the filters were left to cool off in a desiccator in order not to absorb any moisture (silica gel was placed in the bottom of the desiccator). Finally, a precision scale was used for weighing the filters before and after drying (Figure 7).

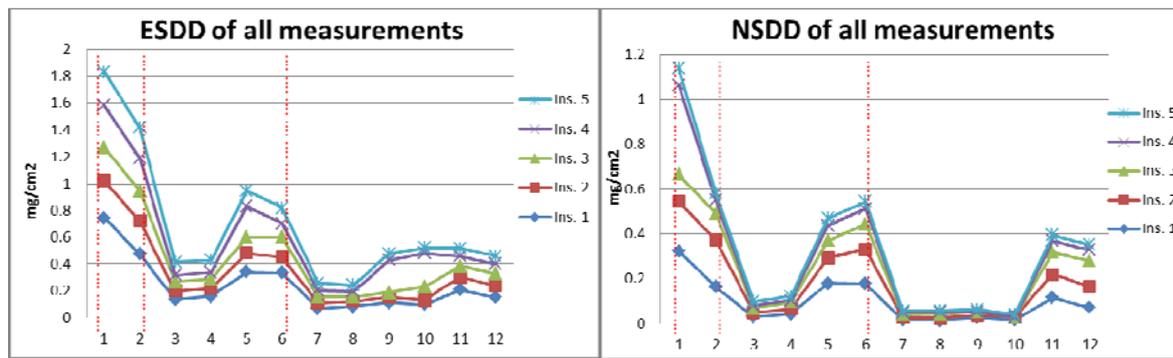
Fig. 21. ESDD and NSDD values of all the measurements (the red dashed lines indicate rain occurrence).

As it is obvious the disc profile insulator had the higher ESDD value after a month of field exposure and the fog profile insulator had the lower (Figure 20). During the same time period Teflon insulator accumulated the most NSDD pollutants, while the disc profile and the HTV SIR insulators accumulated the less (Figure 20). It must be noticed that there was a long period with high temperatures and no rain occurrence before the second set of measurements took place. Also, the relatively to the season, intense rainfall before the third set of measurements determines the self-cleaning properties of the specimens and probably explains the fact that almost all insulators had lower ESDD-NSDD values at the third compared to the second measurement. Thus, an interesting remark comes from the fact that fog profile insulators (both glass and RTV-SIR coated) seem to collect the lowest ESDD pollutants after the specific rainy period, although disc profile insulators tend to collect less pollution due to their aerodynamic profile and good natural cleaning (Figure 21).
