# Structural Behavior of Concrete One-Way Slab with Mixed Reinforcement of Steel and Glass Fiber Polymer Bars under Fire Exposure

## ABSTRACT

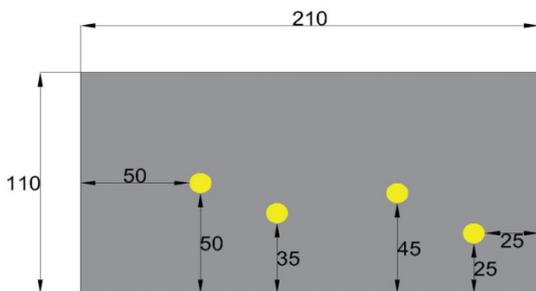
Before the specimens were prepared, a 400 × 210 × 110 mm miniature model with a compressive strength of f<sub>cu</sub> = 40 MPa was cast and reinforced by four GFRP bars, the mix proportion is displayed in Table III. As discerned in Figure 1, the model was cast on a variety of concrete covers. The model was coated with water-soaked canvases that were sprayed every day. The miniature model was then subjected, in compliance with ASTM E-119, to fire at a steady-state temperature of 500 °C for 1 hr (Figure 2). When the fire exposure ended, rapid cooling technique (water spraying) was used to chill the model. After that, as observed in Figure 3, the model was broken and the GFRP bars were removed. The GFRP bars on the sides were seen to be burned, and it was discovered that the middle cover, which was 45 mm from the bottom, best prevented burning.

Fig. 1. Dimensions of a miniature model (mm).

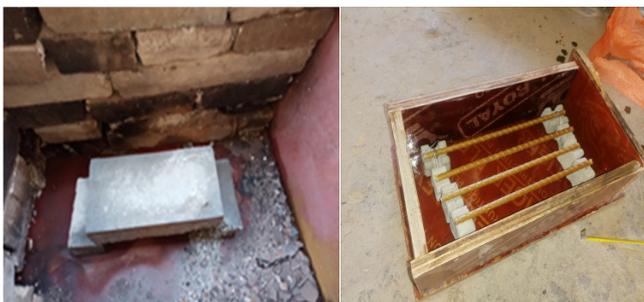
Fig. 2. Casting and burning of the miniature model.

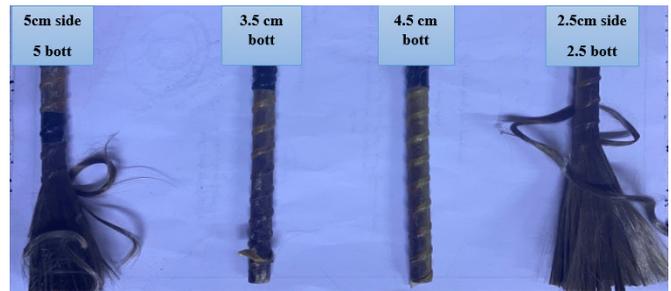
Fig. 3. Condition of the GFRP bars after exposure to fire.

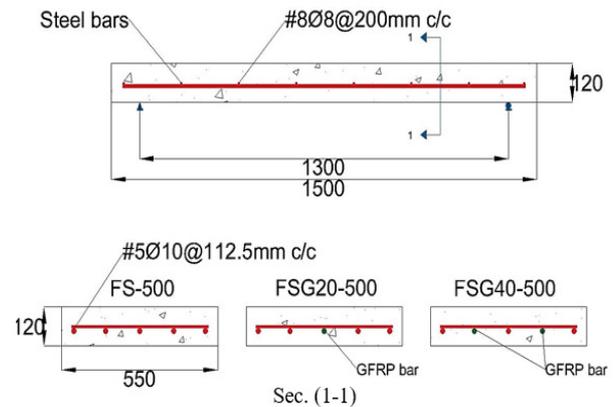
The experimental program included testing three identical concrete slabs with the same geometric layout and concrete compressive strength. Each slab was 1500 mm, 550 mm, and 120 mm in length, width, and depth, respectively. Additional details regarding the test specimens are portrayed in Figure 4 and Table IV.

Fig. 4. Dimensions and reinforcement details of the specimens.

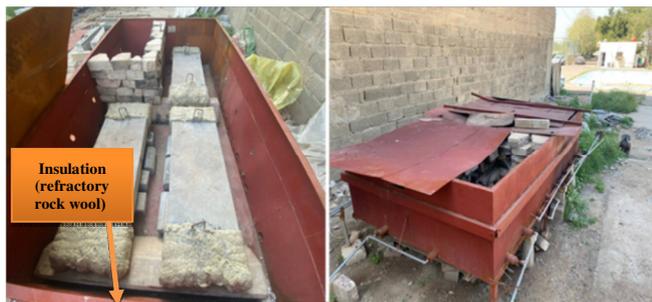
As shown in Figures 5 and 6, the specimens were set inside a gas furnace and were exposed to a direct flame for 1 hr while keeping the temperature steady at 500±10 °C. A digital thermometer reader fitted with sensor wire type K was used to track the temperature of the specimen and furnace region, according to ASTM E-119 [30]. The specimens were sprayed with water (sudden cooling) to lower their temperature after the burning procedure.

Fig. 5. Setup of the furnace and specimens.

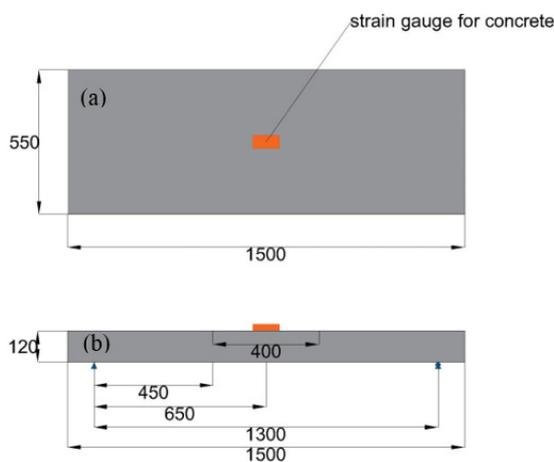
Fig. 7. Locations of the strain gauge: (a) Top face, (b) side face (mm).

loading, I-section girder equally distributed the load, producing two equal forces divided by a 400 mm span. Several measurements were made during the experiment, including the strain experienced by the concrete surface, the applied load amplitude, and the vertical deflection at the center of the slab. Every stage of the loading procedure involved recording of these measurements. Each phase of the load process entailed a 2.5 kN increase until failure occurred. The crack formation was meticulously monitored and recorded following each step. See Figures 7-9 for a more thorough explanation of the experimental setup.

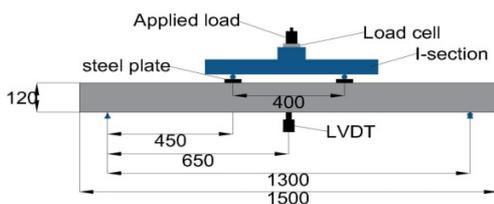
Two hemispherical supports, intended to offer straightforward support, were attached to the slabs. The length of the slabs under examination and the measurement of the distance between the supports were 1300 mm. After that, a 100-ton hydraulic jack was used to apply the load. A steel

Fig. 8. Details of the test setup (mm).

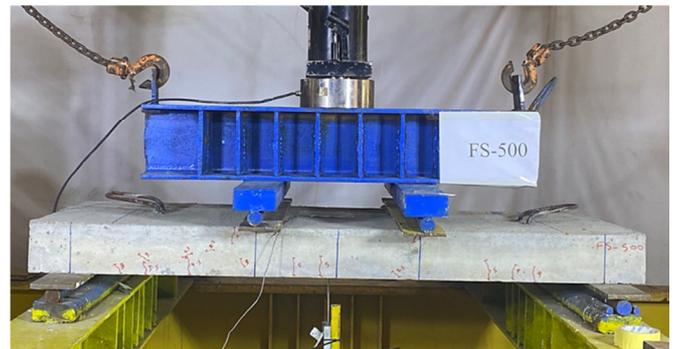
An application of a two-point load was utilized to test three reinforced concrete slabs with different ratios of GFRP bars in place of steel bars as depicted in Figure 9. The load was increased steadily until the point of failure. The discussion comprised four categories to enhance the comprehension of the slab's structural behavior. These are:

Fig. 9. Test setup.

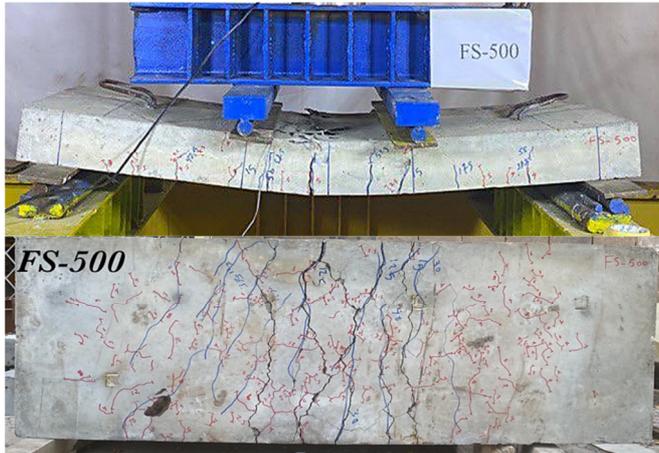
The results for the burned specimens revealed that, after the firing and cooling process, cracks began to occur on the slabs' surfaces. Flexural cracks were also developed as an outcome of the fire in the slabs' sides and bottom. Once the burning and cooling procedure were completed, the specimens were put through a two-line static load test. As exposed in Table V, the variation in the ultimate load for the specimen FSG20-500 was +2.62% compared to the reference slab, whereas it was decreased by 3.13% for the specimen FSG40-500. The reduction in strength and mechanical properties of concrete material prevents the flexural reinforcement from reaching its maximum ultimate strength. Consequently, no significant influence was observed regarding the effect of glass fiber bars.

The slabs FS-500 and FSG20-500 experienced flexural failure while the slab (FSG40-500) experienced shear failure. First, additional cracks that emerged from fire fractures in the slab's bottom face were created. Flexural cracks spread along the bottom surface of the reference slab FS-500 and the slab with a replacement percent of 20% (FSG20-500), in a direction parallel to the support direction and the original crack as the stress increased. Cracks began to appear at the failure stage, ultimately spreading to the sides of the slab and the compression chord. The cracks were located in the central third of the slab. None was observed in the vicinity of the supports. The final specimens' breaking pattern is spotted in Figures 10 and 11. These figures unequivocally demonstrate that no fractures were observed in the area of support zones and that flexural cracks are roughly parallel to one another.

Fig. 10. Crack pattern of the specimen FS-500. Top: side face, bottom: bottom face.

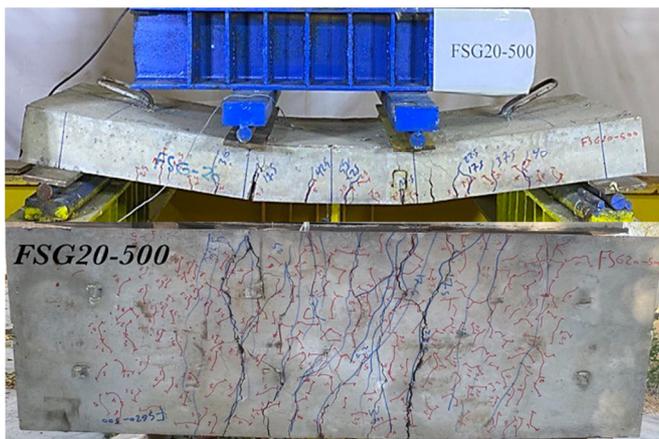
Fig. 11. Crack pattern of the specimen FSG20-500. Top: side face, bottom: bottom face.

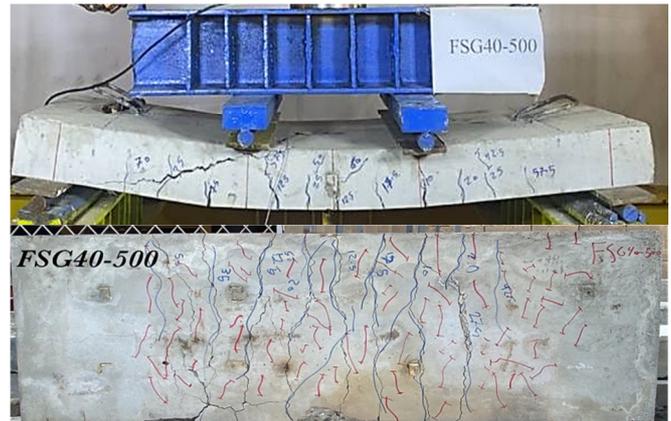
In the slab FSG40-500, in which the substituted ratio was 40%, the pattern of the cracks was completely different. As the applied load increased, more flexural fracture development and propagation were observed on the slab's bottom surface. The supports' orientation and the initial fracture were parallel to one other. Subsequently, diagonal shear cracks started to propagate along the slab's sides. When the applied load was gradually increased, the shear fractures in the slab seemed to get larger and travel toward the loading location. As soon as the diagonal shear cracks were generated by the debonding of the GFRP bars, the slab collapsed. Due to the 40% replacement percent (2 from 5 bars) that increased the slab's flexural resistance, shear failure mode rather than flexure mode occurred.

Fig. 12. Crack pattern of the specimen FSG40-500. Top: side face, bottom: bottom face.

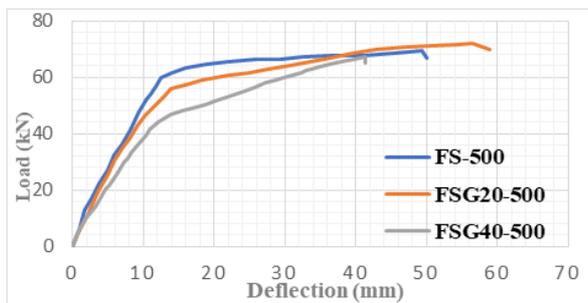
Every load increment during the test procedure involved measuring the deflection at the slab center. The service and ultimate load phases were examined for sample deflection. It is generally assumed that the service load accounts for around 70–75% of the total load [31]. In the current experiment, the service load for each specimen was determined to be the 70% of the ultimate load. The specimens' ultimate loads were calculated based on the maximum bearing load, as illustrated in Table V. Throughout the incremental loading process, several distinct phases were generally observed. In the elastic zone, the deflection first increased gradually and steadily. When cracks began to develop and spread, the deflection rate quickened and accelerated. The deflection curve's slope then started to decline as this pattern persisted until the tension stress in the steel reinforcement reached its yield point. The test is declared to be terminated when the deflection keeps rising without the applied load increasing in proportion. Figure 13 exhibits how the GFRP bar percentage adjustments affect the mid-span load-deflection characteristics. FS-500 serves as the control sample, and the outcomes of the specimens FSG20-500 and FSG40-500 are compared with it. The load-deflection curves evidents that the three slabs' degrees of stiffness vary inside the elastic zone. Table VI showcases the specimens' rigidity (stiffness) at the elastic zone. The results indicate that the stiffness decreased by about 5.18 and 21.29% for a replacement percent of 20 and 40%, respectively.

The trend of the load-deflection comprised two stages. The behavior before the steel reinforcement yield point constitutes the first stage. At this stage, the replacement of 20% demonstrated a behavior slightly similar to that of the reference slab, with an insignificant decrease in stiffness. There was an increase in the deflection, which led to a decrease in stiffness. As for the case of 40% replacement, the deflection increased prominently in the elastic region, and this led to a significant reduction in stiffness and deterioration of the concrete in the elastic region. This difference between the modulus of elasticity of steel and GFRP caused this jump in the structural behavior, as the GFRP has lower modulus of elasticity than steel. In the second stage, which starts after the steel yielding, it can be noticed that the behavior with 20% replacement was similar to that of the reference slab, as the deflection began to increase significantly with a slight increase in the load, i.e. the flexural resistance decreased and led to the flexure failure. In the case of 40% replacement after the point of steel yielding, the GFRP bar had a greater role in increasing load, and the load began to increase with a slight augmentation in deflection. The specimen began to tend toward the brittle (linear) behavior, which is compatible with the GFRP load-strain behavior. This means the flexural resistance increased and led to shear failure.

Fig. 13. Load-deflection behavior at mid-span.

The discrepancy is attributed to the different moduli of elasticity of the steel and GFRP, with the GFRP having a lower modulus of elasticity than the steel, given that all the other parameters of the specimens studied are compatible. In comparison to the control slab, this causes the load-deflection curve for the GFRP-reinforced slab to have a lower initial slope. These results validate the conclusions obtained in [32].

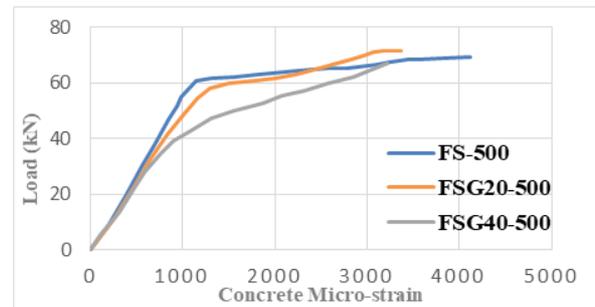
The concrete top surface's strain-load relations were measured at the mid-span. Figure 14 illustrates the effect of increasing the GFRP replacement percentage on the load-strain relations of the top concrete surface at the mid-span. In the elastic zone before the yield of steel reinforcement, the concrete's compressive strain was 710, 802, and 920 micro-strains for specimens FS-500, FSG20-500, and FSG40-500, respectively. This indicates that because steel and GFRP have different elastic moduli, the strain in the elastic area was directly proportional to the replacement ratio. The deflection in the elastic zone increases as the elastic modulus decreases, and the strain in the concrete in the elastic region increases as the deflection increases. The elastic region experienced an increase in strain and a significant decrease in stiffness at 40% material

replacement. Premature shear failure occurred as a result of the concrete's degradation in the elastic zone. The FS-500 specimen had a compressive strain of 4125 micro-strains, the FSG20-500 specimen had a micro-strain of 3362, and the FSG40-500 specimen had a micro-strain of 3220 at the ultimate load.

Fig. 14. Load-strain curves for concrete top fiber at the mid-span.
