# Damage Assessment for Refinement Towers in Oil Installations using 3D Laser Scanning Technique

**Keywords-**Terrestrial Laser Scanner (TLS); 3D modeling; tower; Baiji refinery; as-built drawing

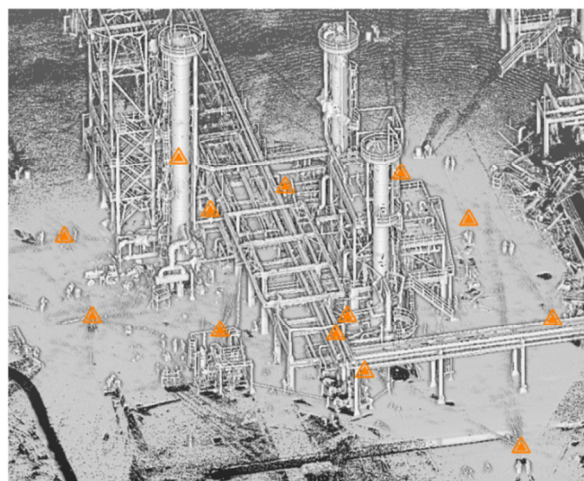
Fig. 1. The three towers and 13 scan stations.

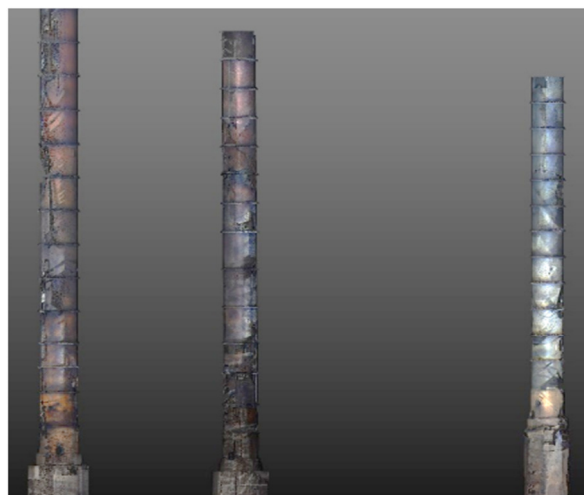
Fig. 2. The three towers after cleaning up.

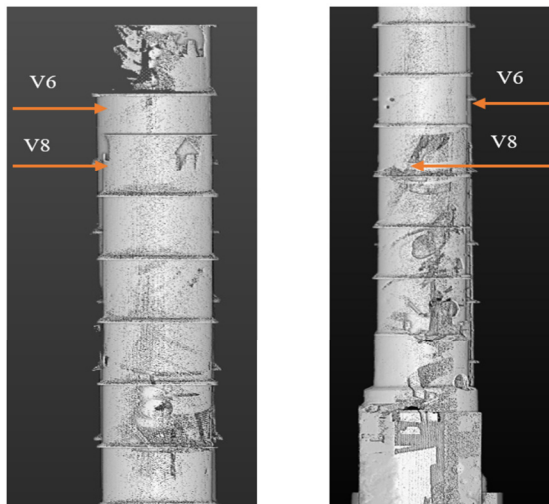
Fig. 3. View from the east.

A comprehensive examination of the inclination of the towers was conducted, encompassing the visualization of all sides: front, back, right, left, top, and bottom. The towers were then rotated along the vertical axis, aligning two towers at a time, to ascertain whether a visually perceptible inclination was present. As depicted in Figure 3, tower V8 is visible, followed by tower V6 in what appears to be a straight line. However, a discernible visual inclination is apparent in the area marked by the red rectangle. Upon zooming out, it becomes evident that the two towers are not aligned in a straight line. Instead, an observable inclination is present on two distinct sides, at the top and bottom, with the towers converging in the medial plane, as presented in Figure 4.

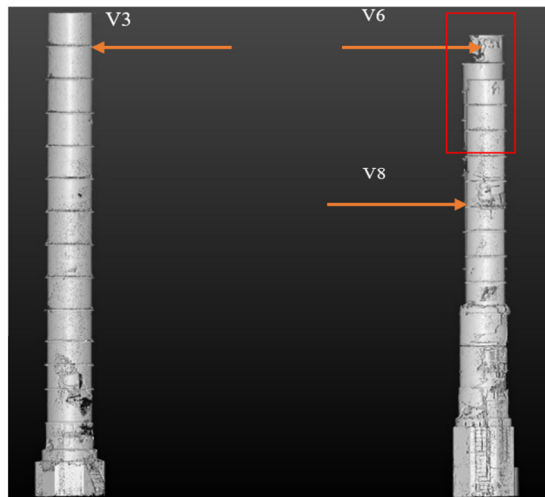
Fig. 4. Towers V8 and V6 are applicable.

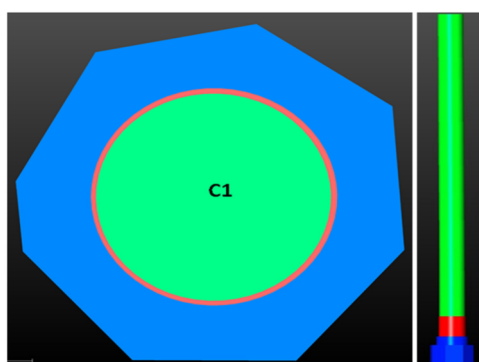
each tower in a specific direction and magnitude. The cylindrical concrete base, being vertical and without deviation or inclination, serves as the reference point for measuring inclination, as evidenced in Figure 8.

Fig. 8. Front and top view, illustrating the concrete base and the first course in green for tower V3.

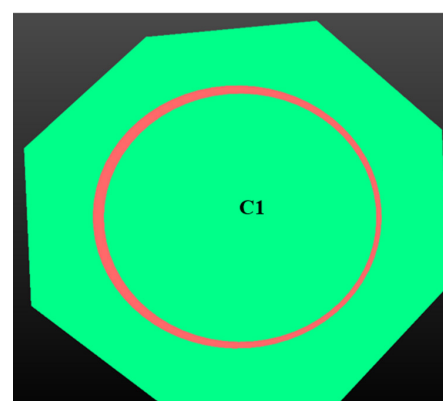
For tower V6, no inclination is observed in the first course (C1), as shown in Figure 10.

Fig. 10. Top view showing the concrete base in red and the first iron base in green in tower V6.
