Investigation of an Insulator Flashunder in an 150 kV OTL of the Power System of Crete

Islands Network Operation Department
Hellenic Electricity Distribution Network Operator S. A.
Greece
d.pylarinos@deddie.gr

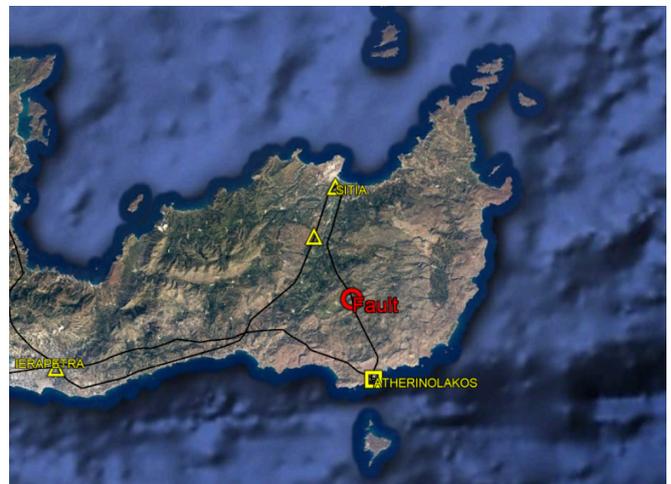
Fig. 3. The considered transmission line and the location of the fault at Tower 29 (screenshot from Google Earth. Image © 2019 CNES/Airbus, Map data: Data SIO, NOAA, U.S. Navy, GEBCO).

The fault was found in one of the two insulators in a double tension string in Tower 29, located 13.73 km away from Sitia. Towers 28 and 29 are double circuit tension towers with the extra circuit endings being used in a way that facilitates a phase transposition (Figure 5), the only one in the Cretan Transmission System. These towers, known to suffer from strong winds and intense humidity in early mornings, are located at the top of a steep hill (Figures 6-7). For all these reasons, and even though the distances recorded from the fault

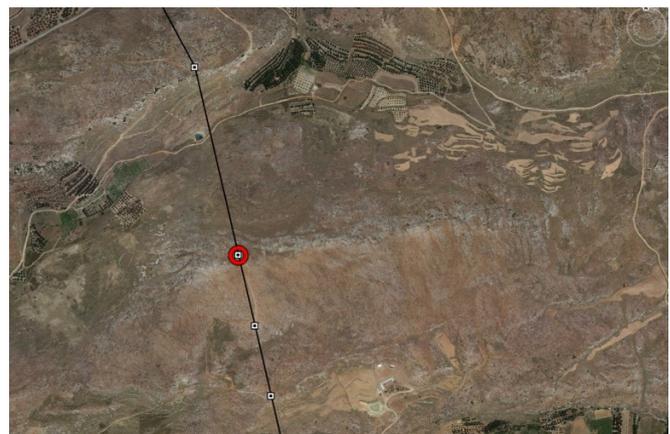
Fig. 7. The location of Tower 29 (red circle) on top of a steep hill (screenshot from Google Earth, Map data: Google Earth)
