# Overhead Transmission Line Maintenance in Crete and Rhodes: 2016-2020

D. Pylarinos

Islands Network Operation Department  
Hellenic Electricity Distribution Network Operator S. A.  
Greece  
d.pylarinos@deddie.gr

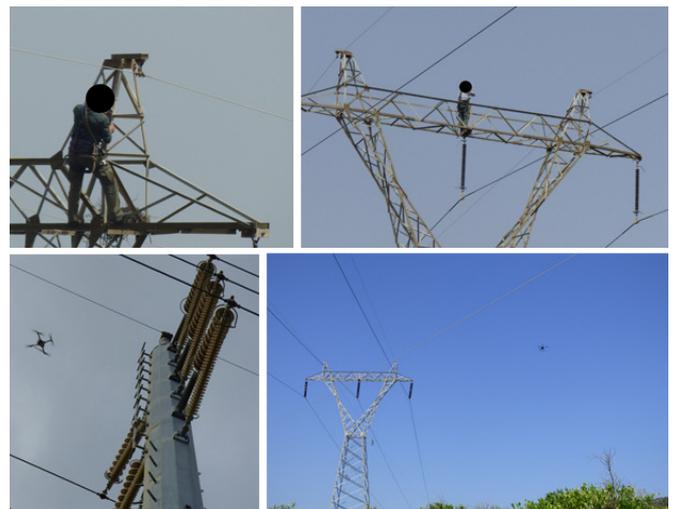
Unmanned Aerial Vehicles (UAVs) provided a better solution. Such drone inspections can be carried with the circuits live and, with proper equipment, from a safe distance (Figure 12). In addition, when using a drone, viewing angles can be altered on site in order to safely assess the severity of issues. Adding an experienced lineman in any drone inspection team offers the ability of on-the-spot assessment of issues, significantly reducing the inspection times (compared to the later assessment of tens of pictures per tower). Climbing inspections still remain necessary as some parts of the tower (e.g. the upper fitting of the yoke plate in the down and left image of Figure 9) can only be inspected from a close distance. A comparative view of images taken through different inspection approaches is provided in Figure 13.

Fig. 12. Climbing and drone inspection. Up: Climbing inspections. Down: drone inspections. Note that a no-zoom drone has to approach to a very close distance (left image) but a suitably equipped drone can perform inspections from a safe distance (right image).
