Theoretical and Experimental Investigations on 20 Inches Threaded Casing Connections Failure under Field Conditions

Abstract-This paper brings forward the results of theoretical and experimental investigations performed to determine the causes that led to the failure of 20 inches threaded casing connections during the tubing of the Lupşa Sat No. 1 oil well, Romania. The failure occurred due to the breakout of the threaded casing connections assembled in the factory. In order to establish the main causes of failure, theoretical investigations were taken into consideration to highlight the influence of the thread element errors on the correct make-up casing pin-coupling (box) conditions and to the axial tensile strength of the threaded casing connection. In addition, experimental investigations were performed on the failure casing connections, consisted of measuring the dimensional characteristics of the thread elements to determine the performance and monitor the technical condition of the tubular material used in the petroleum industry.

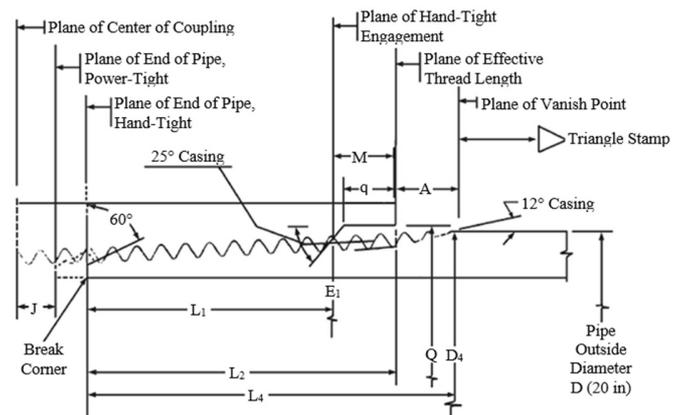
Fig. 3. Round threads casing connection.

The casing connection involved in this accident, manufactured according with the API Specification 5CT/ISO 11960 and API Specification 5B, is a threaded connection for casing having an outer diameter of 20in, material grade type J55, and wall thickness of 11.13mm, fitted with a round thread type API 8-Round (Figure 3) [7]. The box of the casing connection has an outer diameter of 21in and a length of 230mm.
