# Damage to Natural Gas Distribution Steel Pipelines caused by Rigid Bodies resulting from the Excavation of Laying Trenches

## ABSTRACT

The present paper focuses on analyzing the occurrence of defects such as dents and local deformations by laboratory simulations of a real case of a defect detected on a natural gas distribution pipeline laid at a depth of approximately 0.6 m. The defect is caused by a river stone which due to the compression forces, damages the pipe to the point of cracking. In the laboratory, the simulation was carried out on a steel pipe insulated with extruded polyethylene which was acted upon by a mandrel made of duralumin. The purpose of the tests is to determine the maximum values at which the pipe material fractures. It was found that the fracture of the pipes when there are rigid bodies in the protective layer of sand is accelerated by the sand existing between them and the pipe and by the change in the properties of the steel the pipes are made of when they are kept in water.

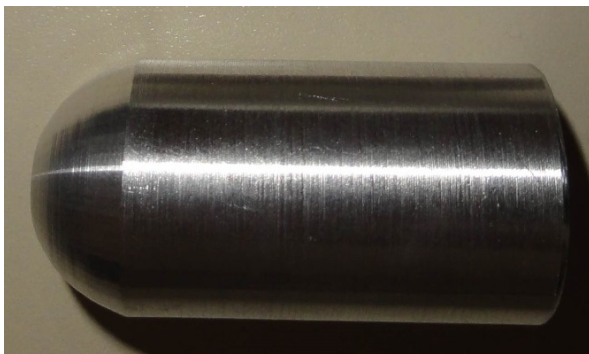
Fig. 2. Mandrel made of hard aluminium.

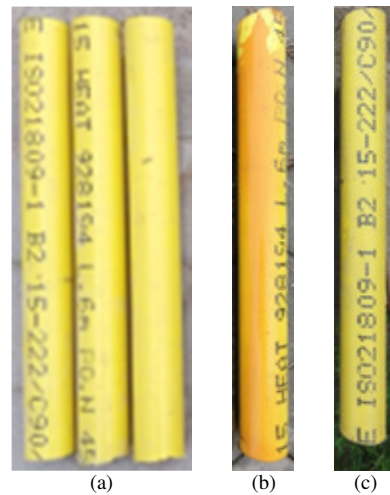
For the experiment, we substituted the section of the pipe where the defect was detected with L245 steel pipe segments, having  $\varnothing$  60.3 mm diameter and 3.6 mm wall thickness, insulated with class B PEHD high-density polyethylene, with an applied thickness of 1.8 mm. The tests were carried out on three sets of pipes with a length of 600 mm: one set was kept in its original state, the second was kept in rainwater for 72 hr, and the third was kept in loam sand for 72 hr (Figure 3).

Fig. 3. Specimens of insulated pipe: (a) kept in water (b) or loam sand (c) for 72 hr.

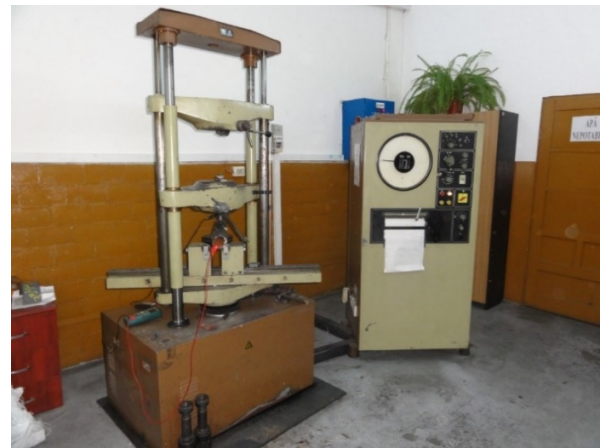
Fig. 4. Compression testing machine.

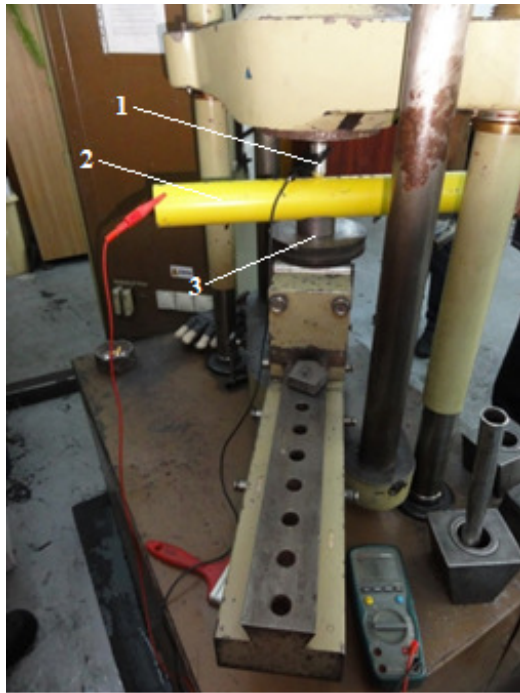
The forces resulting from the compression applied on the upper surface of the pipe section [8] are determined by using the assembly shown in Figure 5.

Fig. 5. Detail of the assembly used for determining the fracture strength: (1) hard aluminium mandrel, (2) steel pipe by type L245, (3) special support to fix the pipe.
