Effect on Fatigue Behavior of Connecting Rod in Gasoline Engine

This article reports the failure analysis of a connecting rod that is broken into 3 pieces and is used in the gasoline engine of a sedan. The connecting rod is made of JIS-S50C medium alloyed steel. Fractography was performed to characterize the failure mode on the fracture surface of this connecting rod through the examination of the macroscopic and microscopic morphologies of the fracture surface, chemical composition, metallographic analysis, mechanical properties of the material, and numerical simulation. The fracture surface of this connecting rod is caused by fatigue, which was the dominant mechanism of failure. This type of crack is indicative of shear failure in the ductile fracture mode, whereas no abnormalities were found in the composite elements of the connecting rod. The microstructure is composed of perlite-ferrite. The results of the numerical simulation and the calculated crushing stress (s_c) were compared and were found to be in accordance and within the acceptable values.

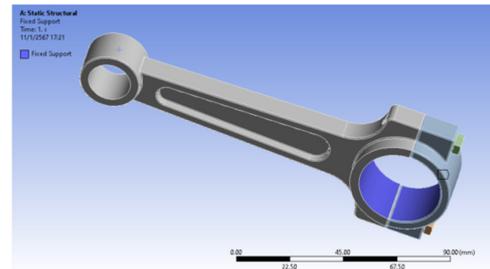
Fig. 11. Three-dimensional model of the connecting rod obtained from converting Solid work into Ansys Workbench.

The stress analysis using the finite element method in the piston pin subjected to crushing stress was calculated according to the design criteria. A 3D scanner was utilized to measure the shape of the connecting rod, to convert it into the Solid Works 2018 program and put it into a numerical simulation in the Ansys Workbench program as shown in Figure 11.

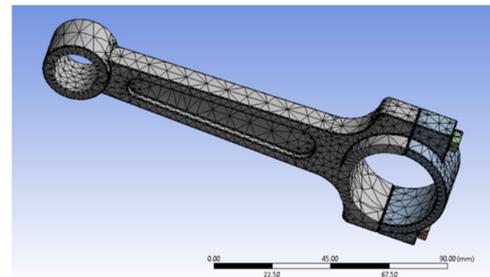
Fig. 12. Mesh obtained from numerical monkey simulation.

The connecting rod mesh adjustment was performed using a torque value of 60 N-m (obtained from the repair manual of this model), the mechanical properties of the connecting rod material were explored using a Young's modulus value of 210G Pa, density of 7.85 g/ cm³ and Poisson's ratio of 0.3 [13]. Mesh (Mesh) is generated with tetrahedral elements as manifested in Figure 12. The generated mesh functional model has a total of 25,646 elements, and a total of 36,762 nodes are selected for mesh control. Each node has a DOF of 5,404 moves only in the x, y, and z directions [18]. The analysis was applied to a connecting rod subjected to torque. After that, the stress distribution was obtained as a number and imported into the Ansys Workbench program, as demonstrated in Figure 13. The Equivalent von Mises stress max value is 645.37 MPa. Figure 14 exhibits the total deformation max value, which is 0.50017 mm, Figure 15 presents the endurance limits max value, which is 106 cycles and Figure 16 provides the safety factor max value [16-25].

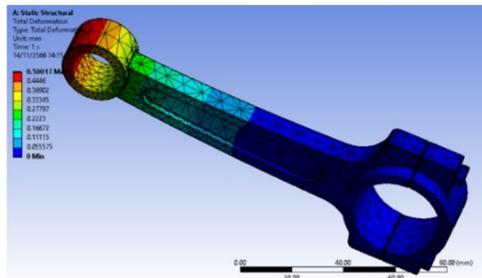
Fig. 14. Total deformation values obtained from numerical simulations.

The calculated crushing stress (σ_c) was 702 MPa, and the numerical simulation results of Ansys Workbench were 645.37 MPa. The results differed by no more than 8%, which ensured

that the program was not compromised. The yield strength of the material is 415M Pa [16-25]. The calculated stress value is 1.69 times greater than the yield strength, which results in the final shaft fracture. In conclusion, if the stress is greater than the yield strength which the material can support, this is the cause of the connecting rod breaking [16-24].
